# FIRST STREET BICYCLE AND PEDESTRIAN SAFETY STUDY

Jacksonville Beach, FL

July 2026

# First Street Bicycle & Pedestrian Safety Study

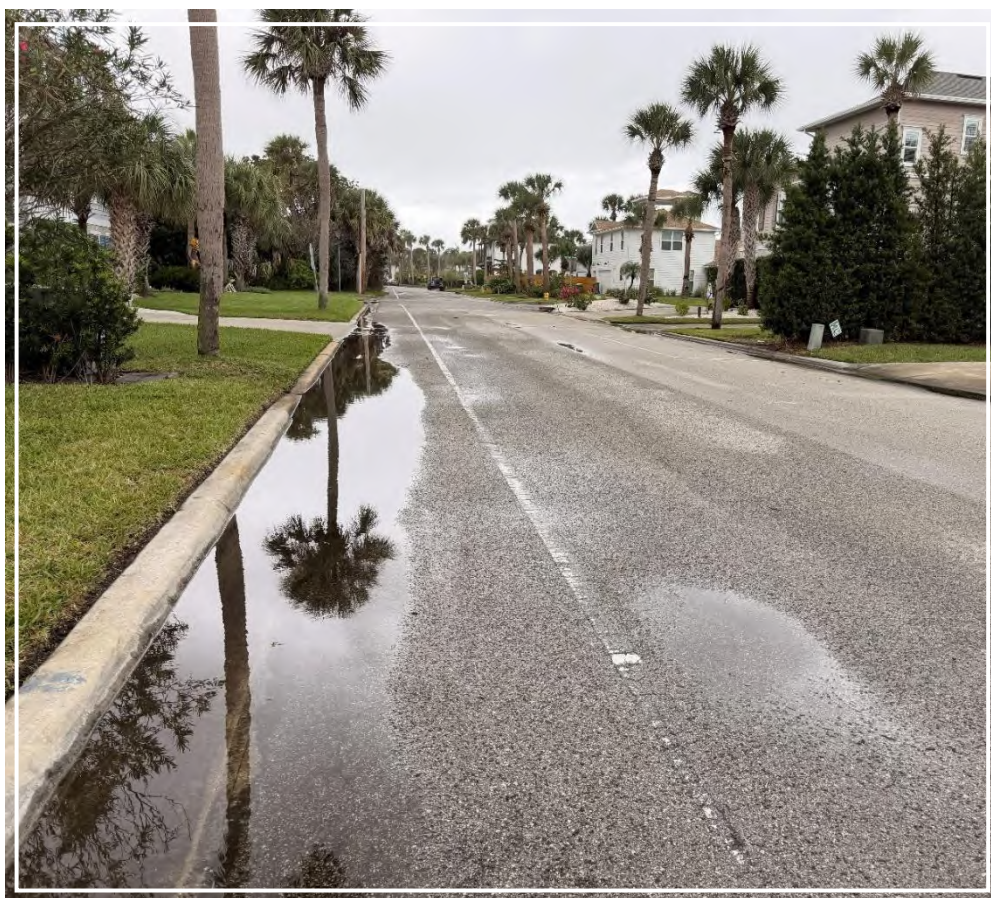
Standing water along First Street after a storm. Source: Project Team.

There is flood risk along the majority of the corridor, with particularly concentrated areas south of Beach Boulevard within Flood Zone AE, which is 1% Annual Chance of Flood Hazard (see **Figure 2-12**).

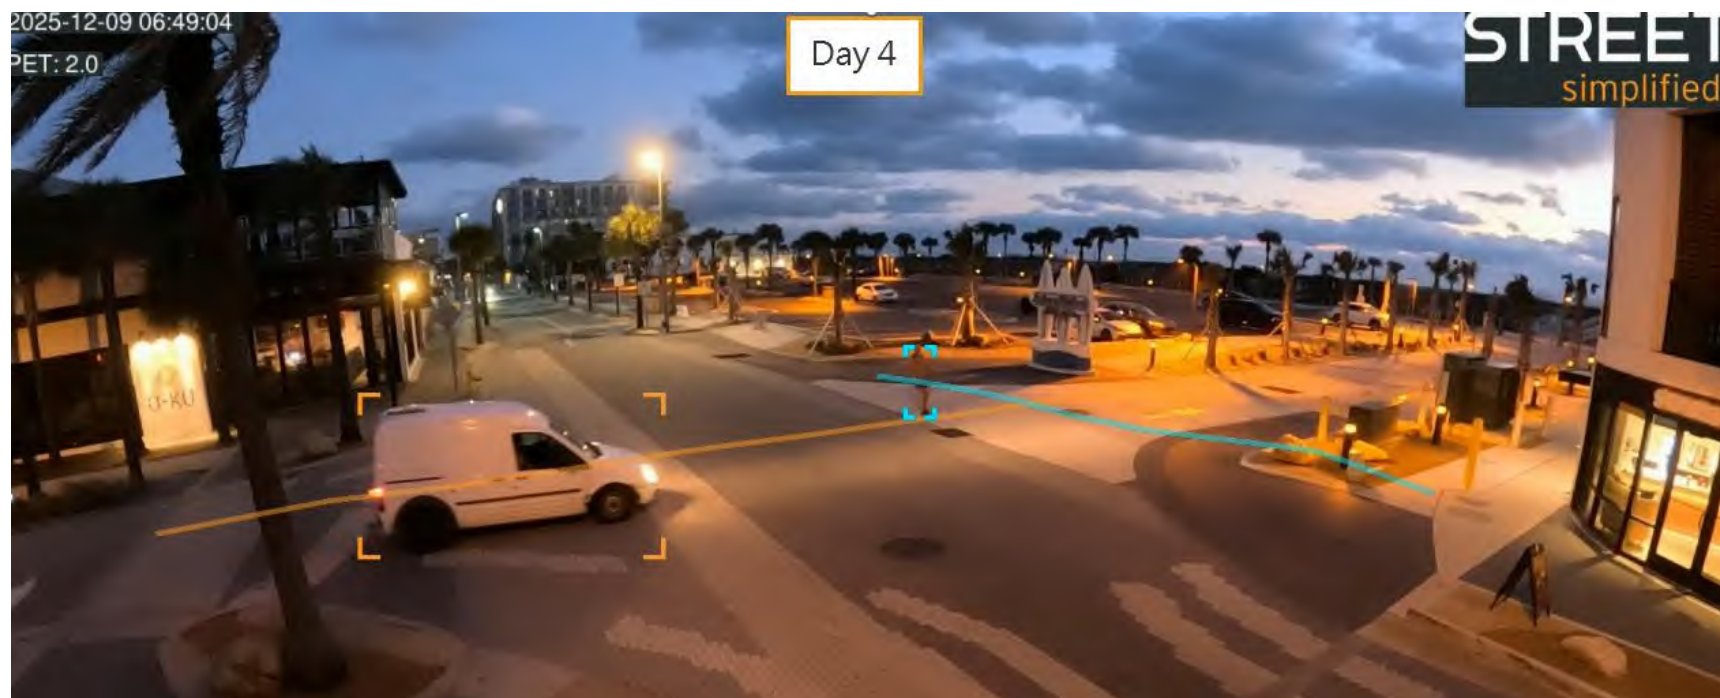
Screen capture of near-miss video of a through-vehicle and pedestrian at 4<sup>th</sup> Avenue North. Source: Street Simplified.

Speed-related behavior was identified as a contributing factor in a subset of near-miss events. Although posted speeds within downtown CA-1 are low, vehicles exceeding the intended operating speed were observed reducing their ability to yield or stop comfortably at crosswalks.

The analysis also identified patterns of **stop-sign non-compliance**, particularly at approaches with lower perceived cross-traffic volumes. In some cases, the majority of sampled vehicles failed to come to a complete stop, increasing risk for pedestrians entering the crosswalk.

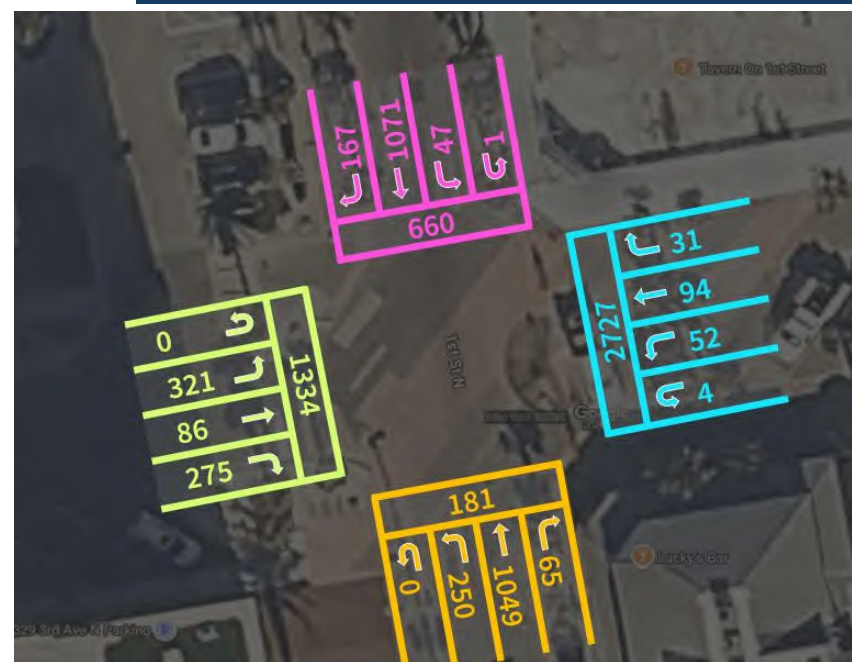
Example Turning Movement Counts. Source: Street Simplified.

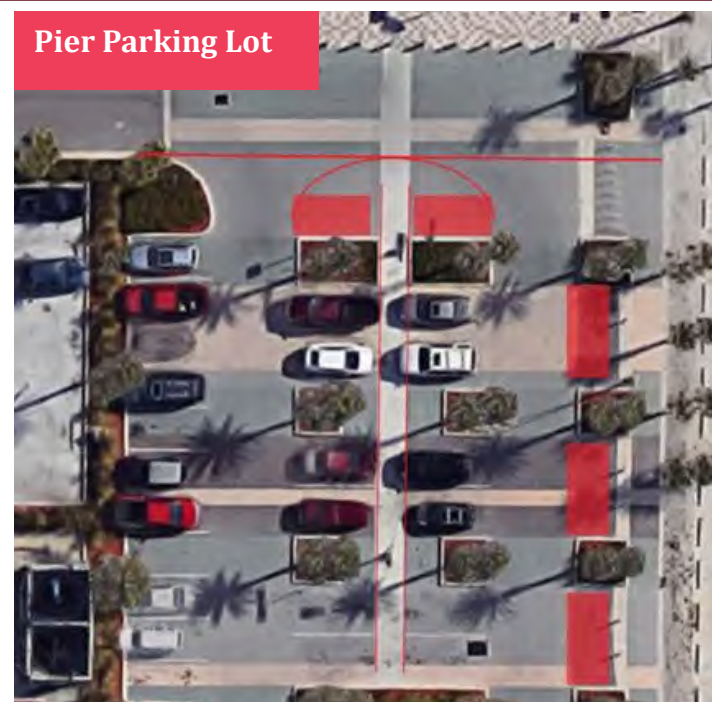
Pier Parking Lot

**Evaluation:** The central parking could benefit from installing wheel stops to prevent vehicles from encroaching into the pedestrian pathway. The parallel spaces are a good example of how bollards can separate user zones. Two additional spaces could be gained if the end of the central rows were striped.

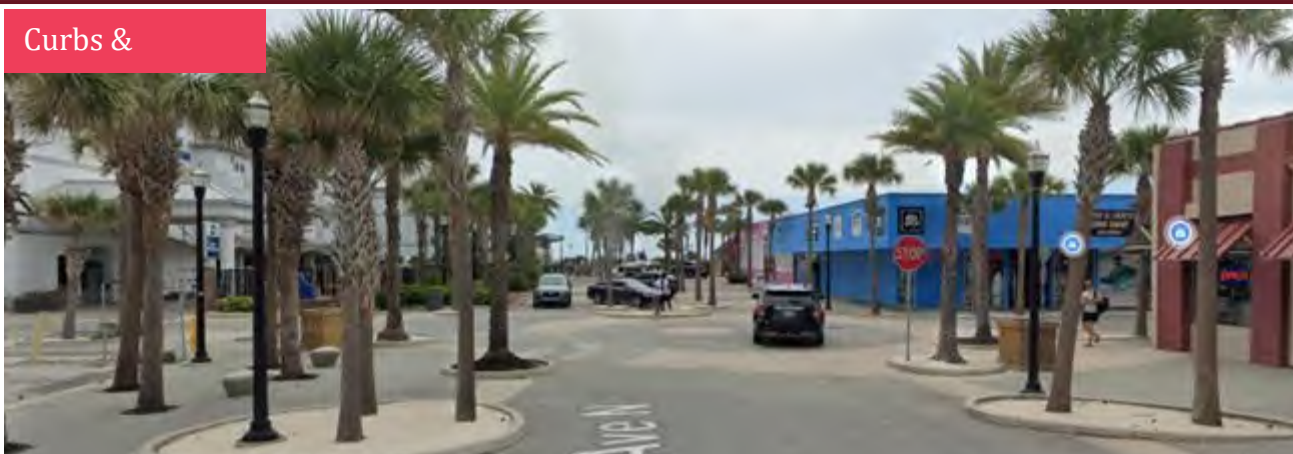
**Description:** This image shows the condition where the planter curbs extend beyond the ex-posed aggregate flush curb pedestrian boundary. Spaces in between the planters are also wide enough for a vehicle to park. You can also see a mix of site furniture types, cast concrete seating set back from the street edge and two types of trash receptacles.

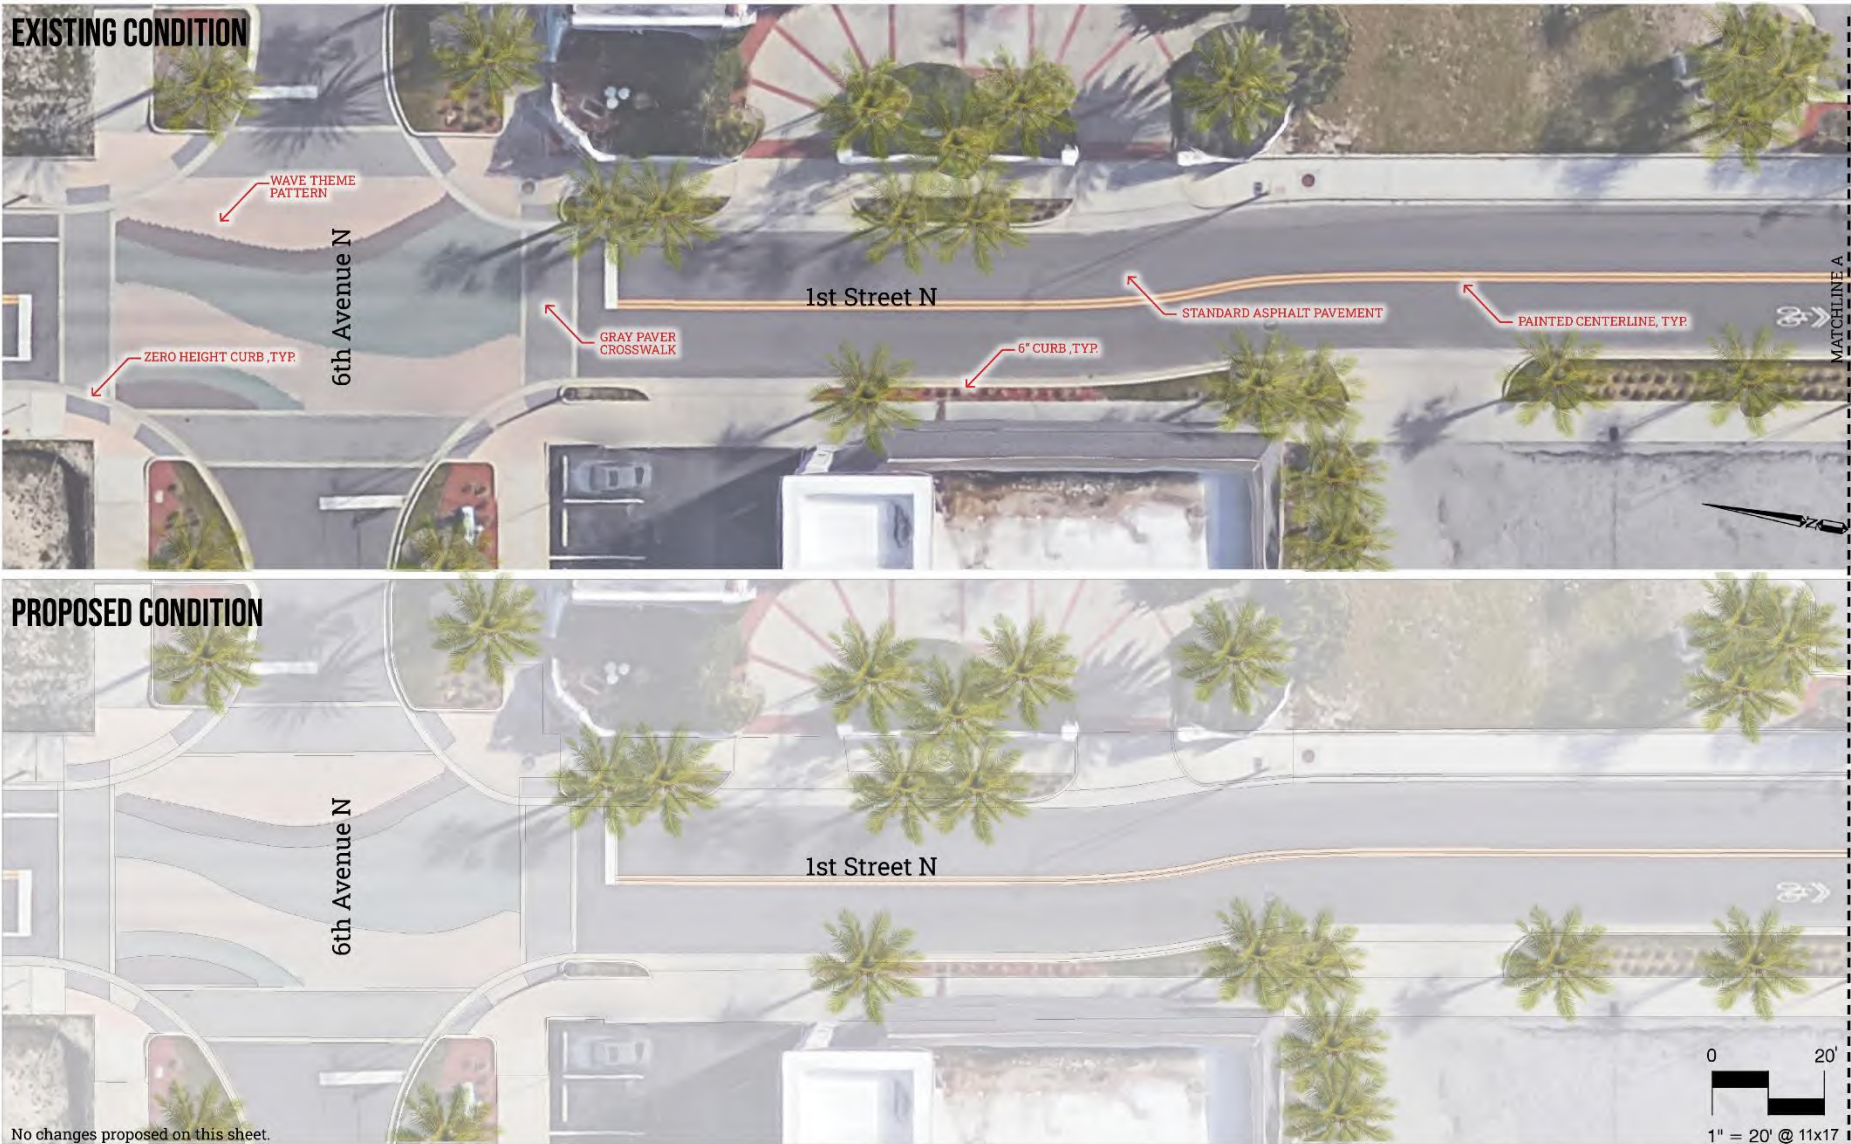
6th Avenue N Streetscape Concept

Proposed Improvements

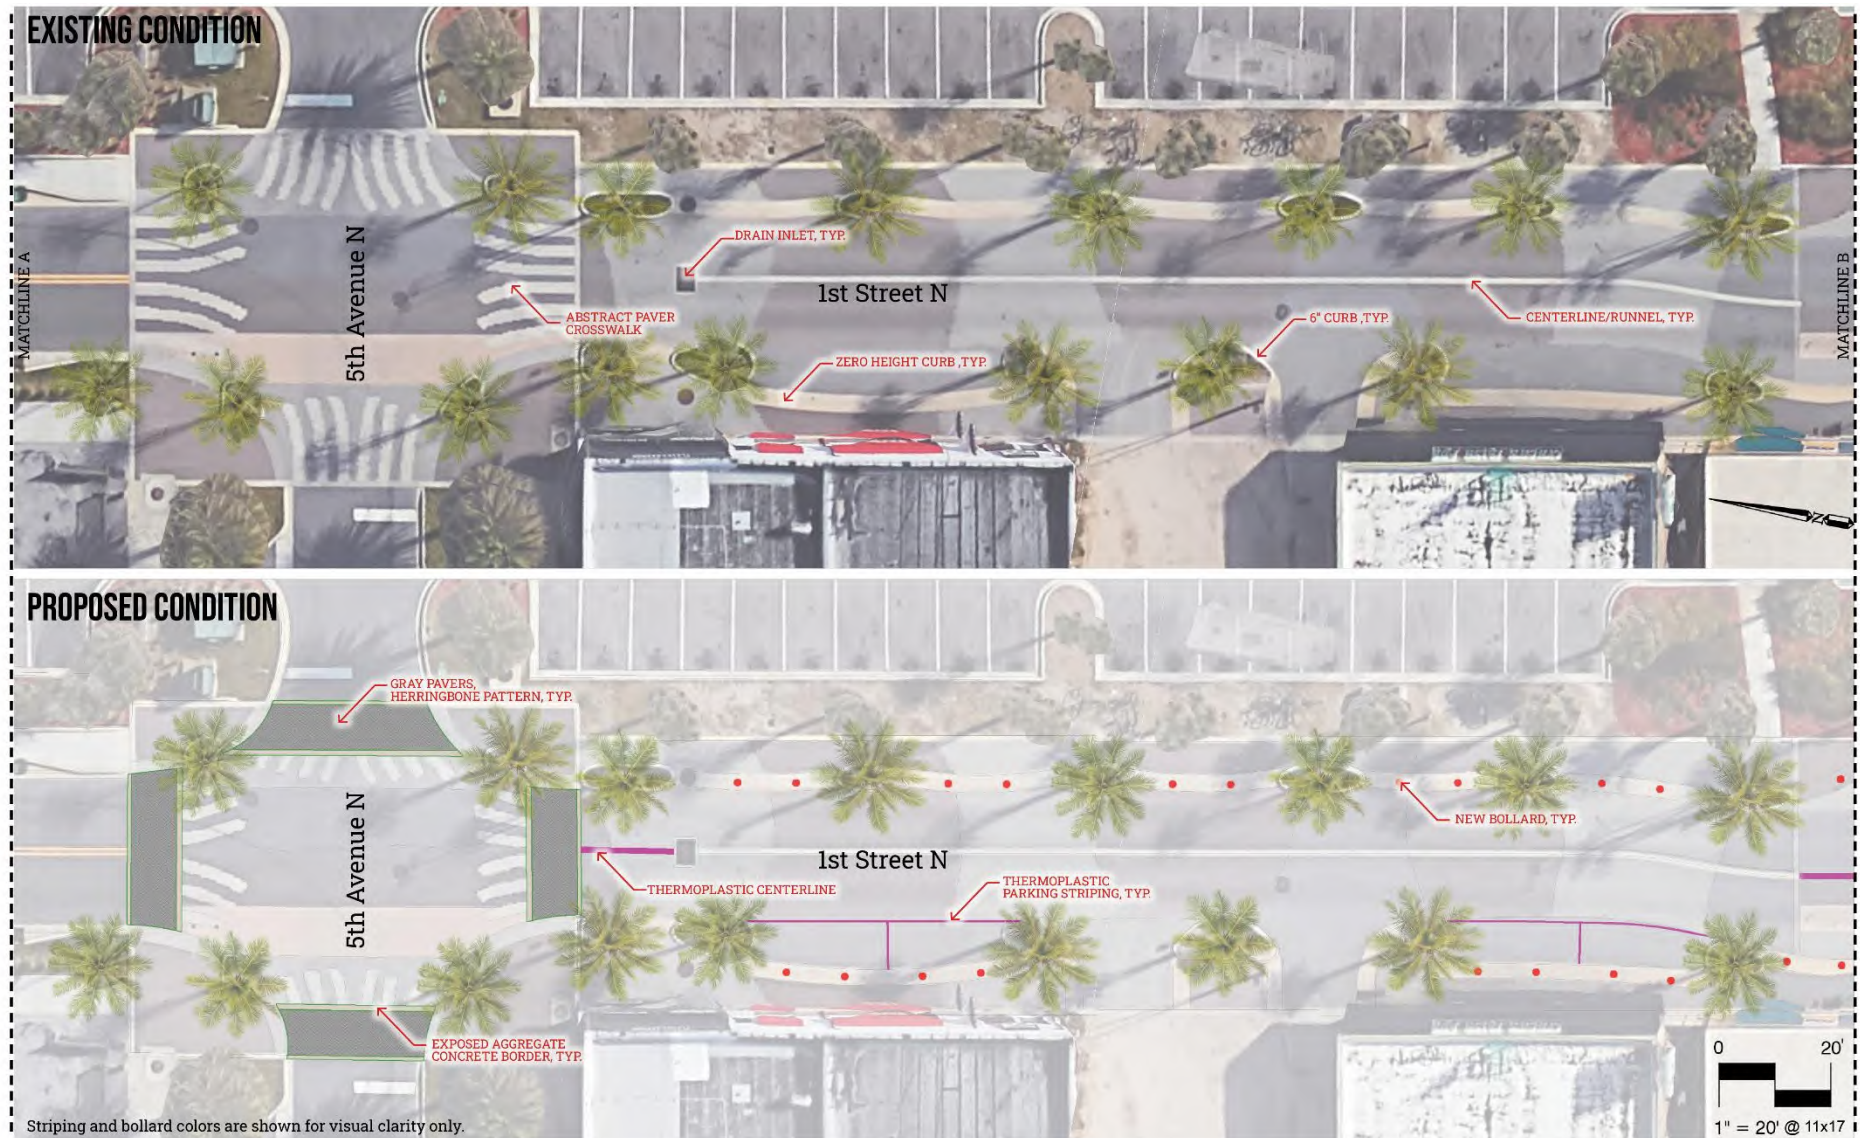
### 5th Avenue N Streetscape Concept

#### Proposed Improvements

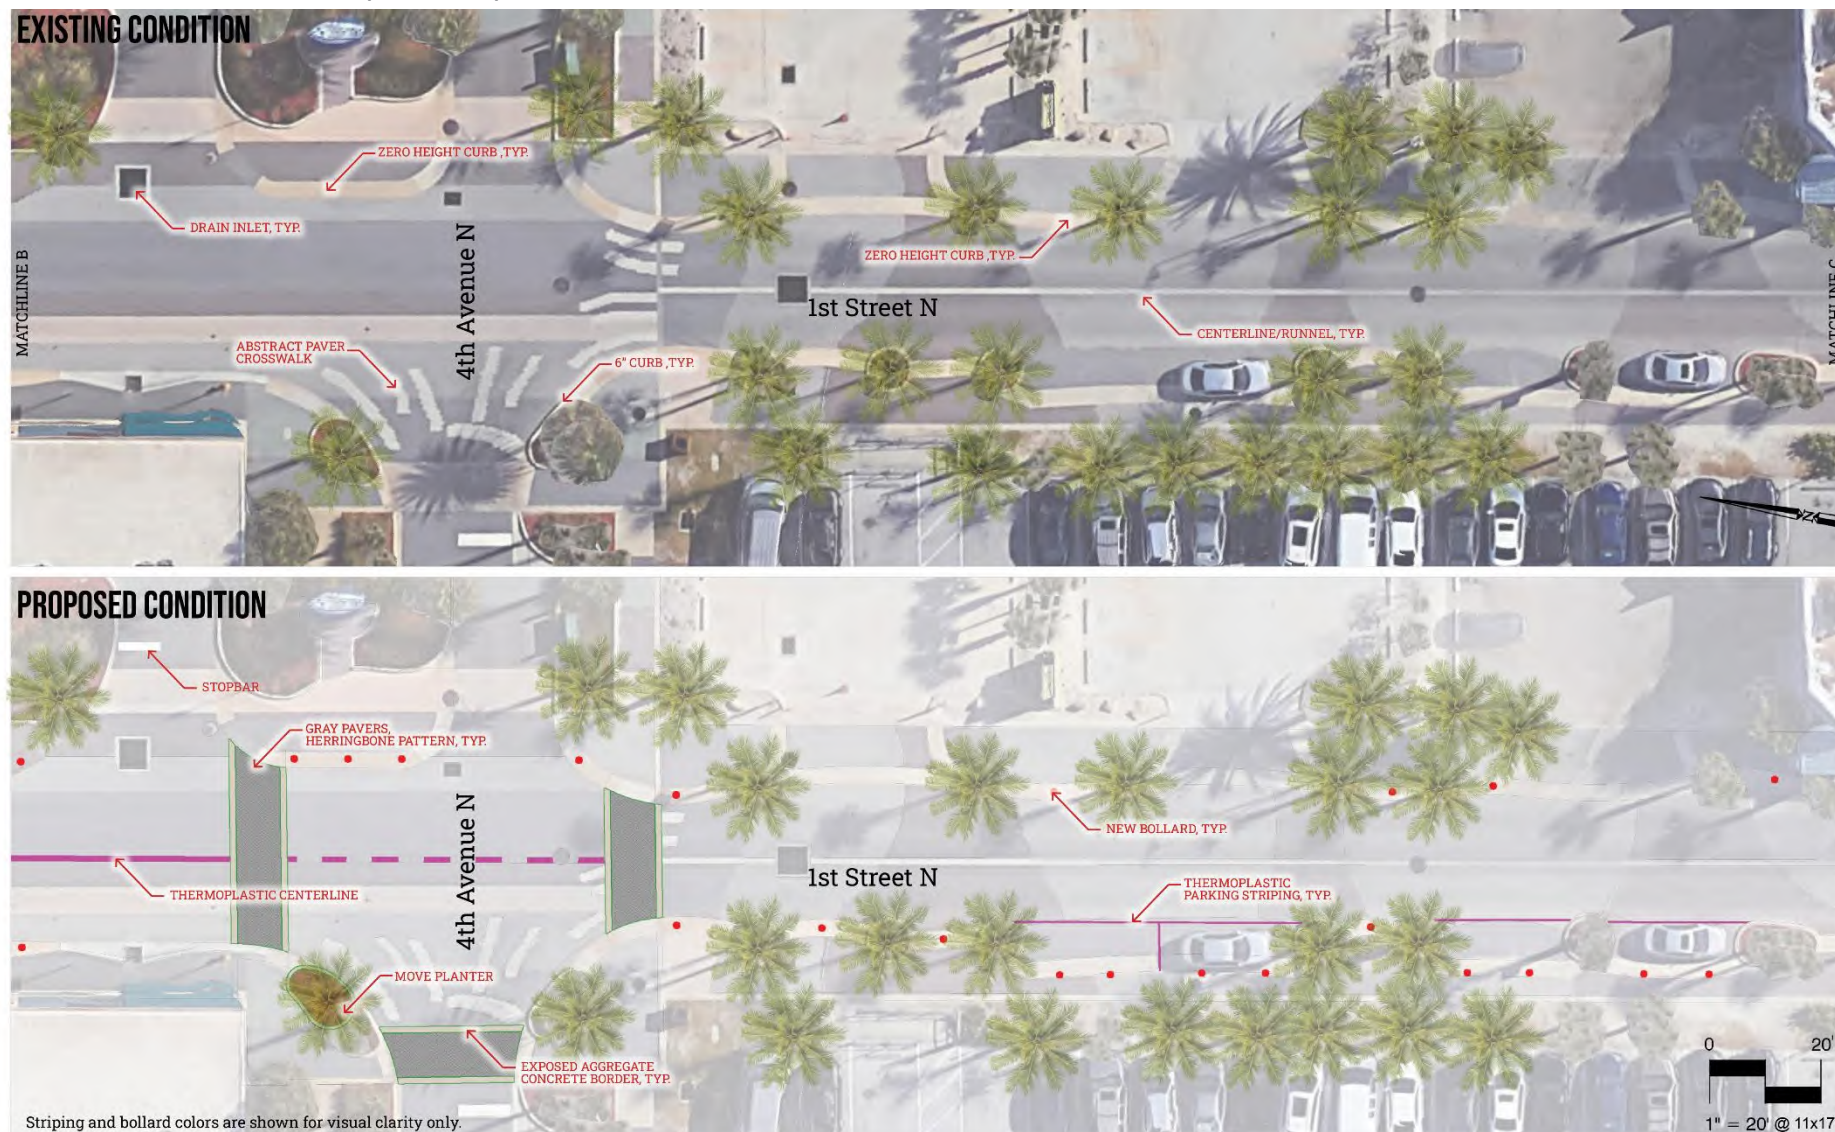
## 4th Avenue N Streetscape Concept

### Proposed Improvements

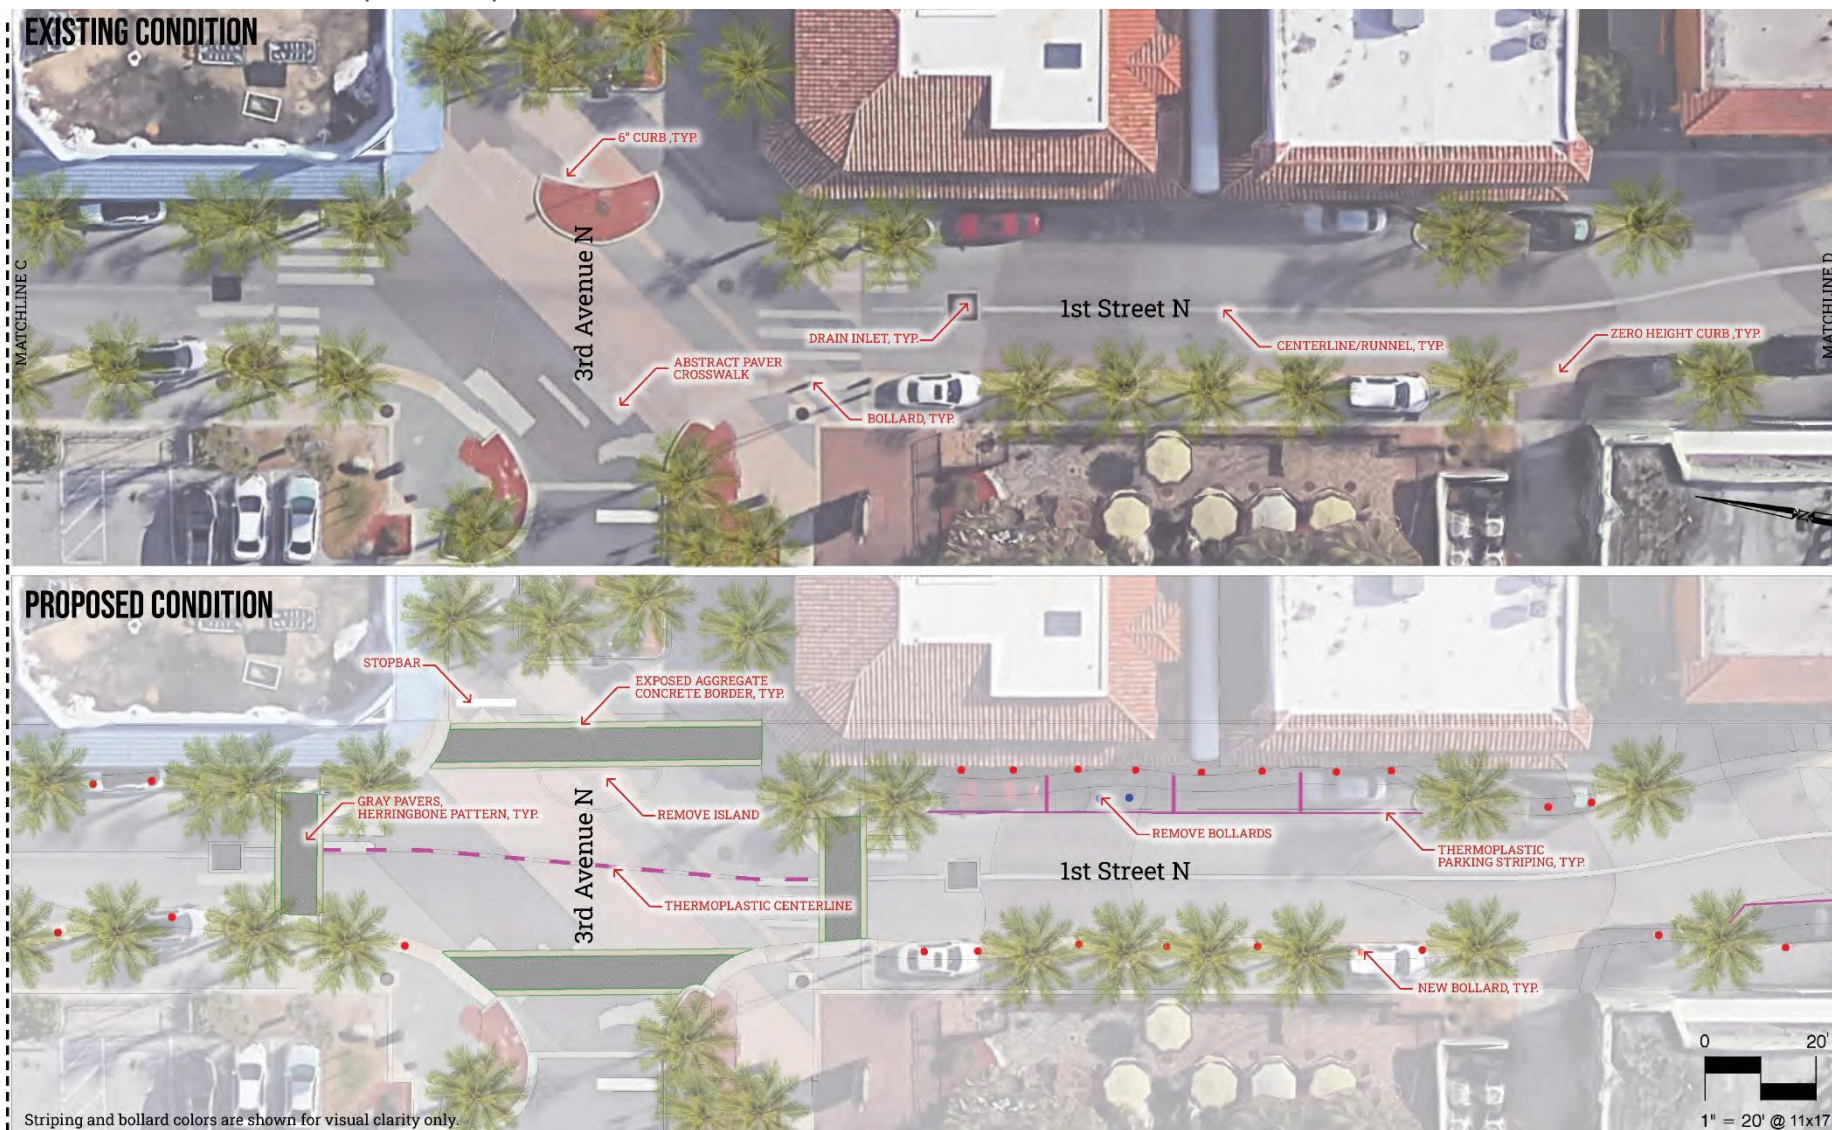
### 3rd Avenue N Streetscape Concept

#### Proposed Improvements

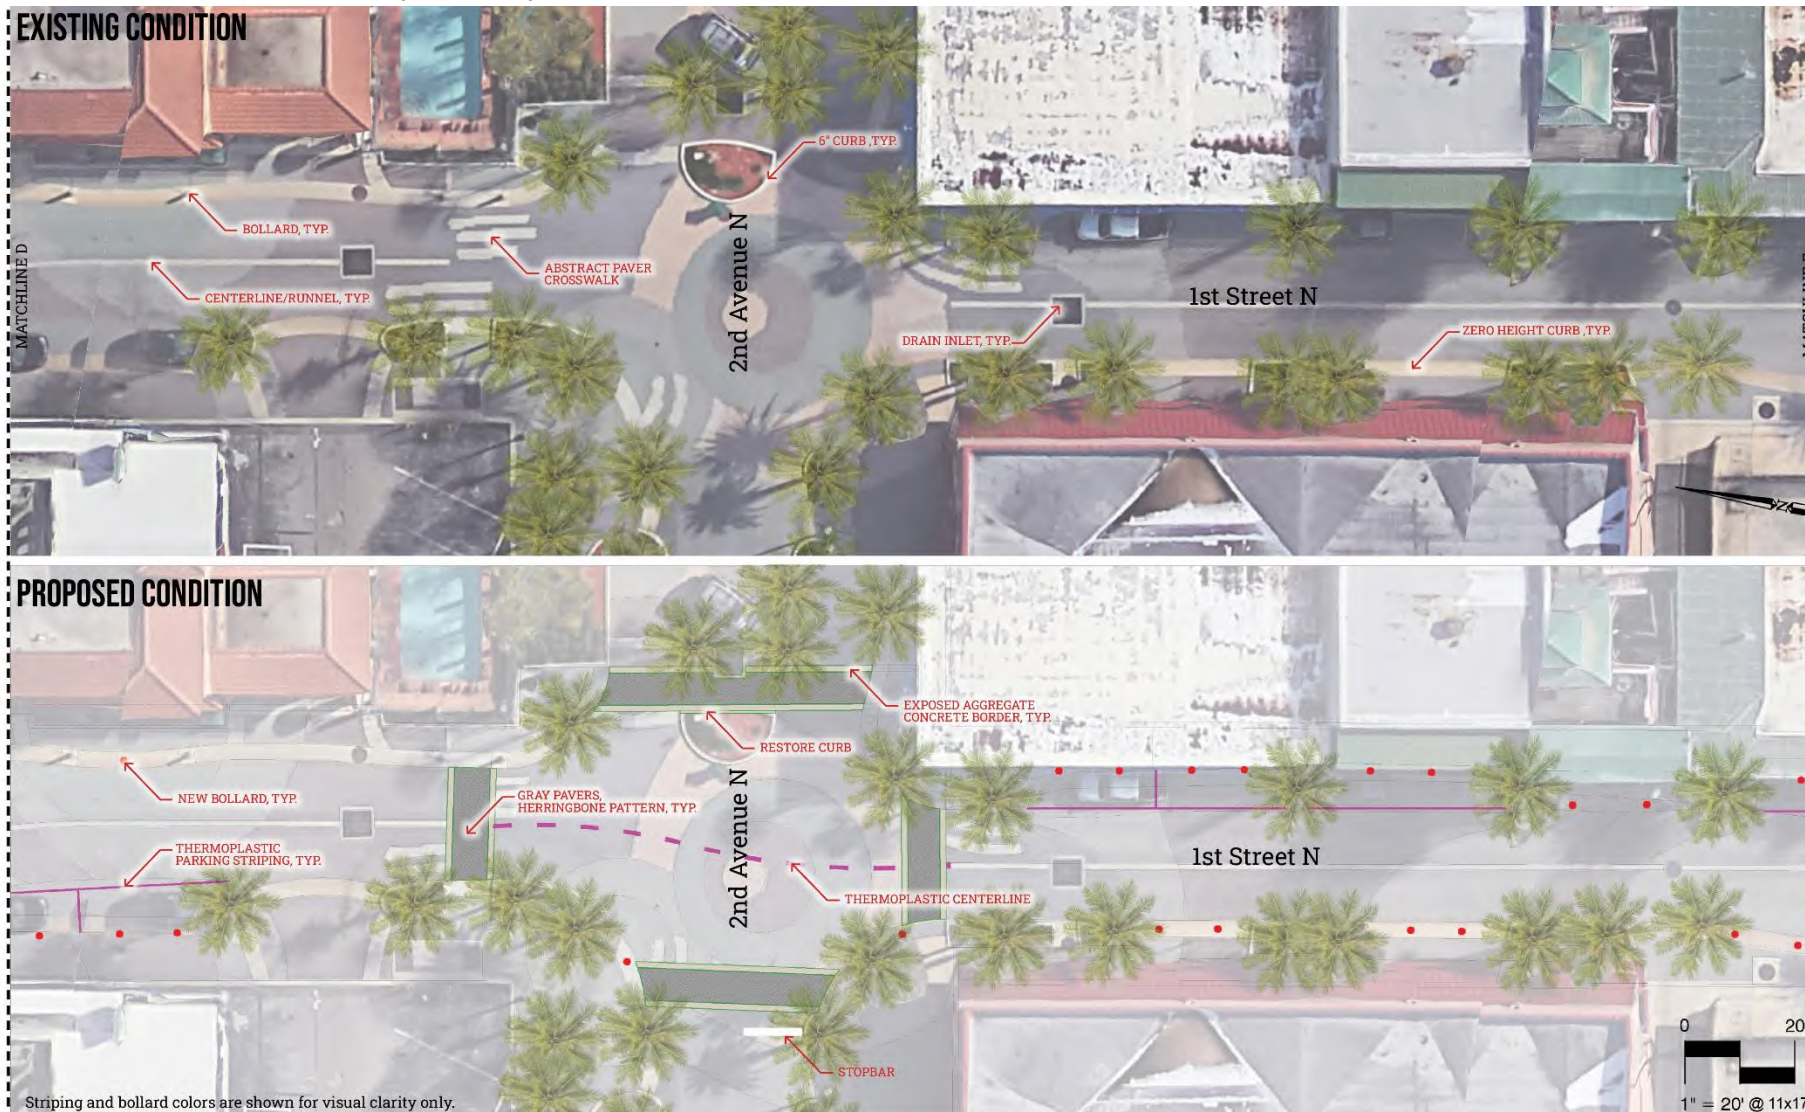
## 2nd Avenue N Streetscape Concept

### Proposed Improvements

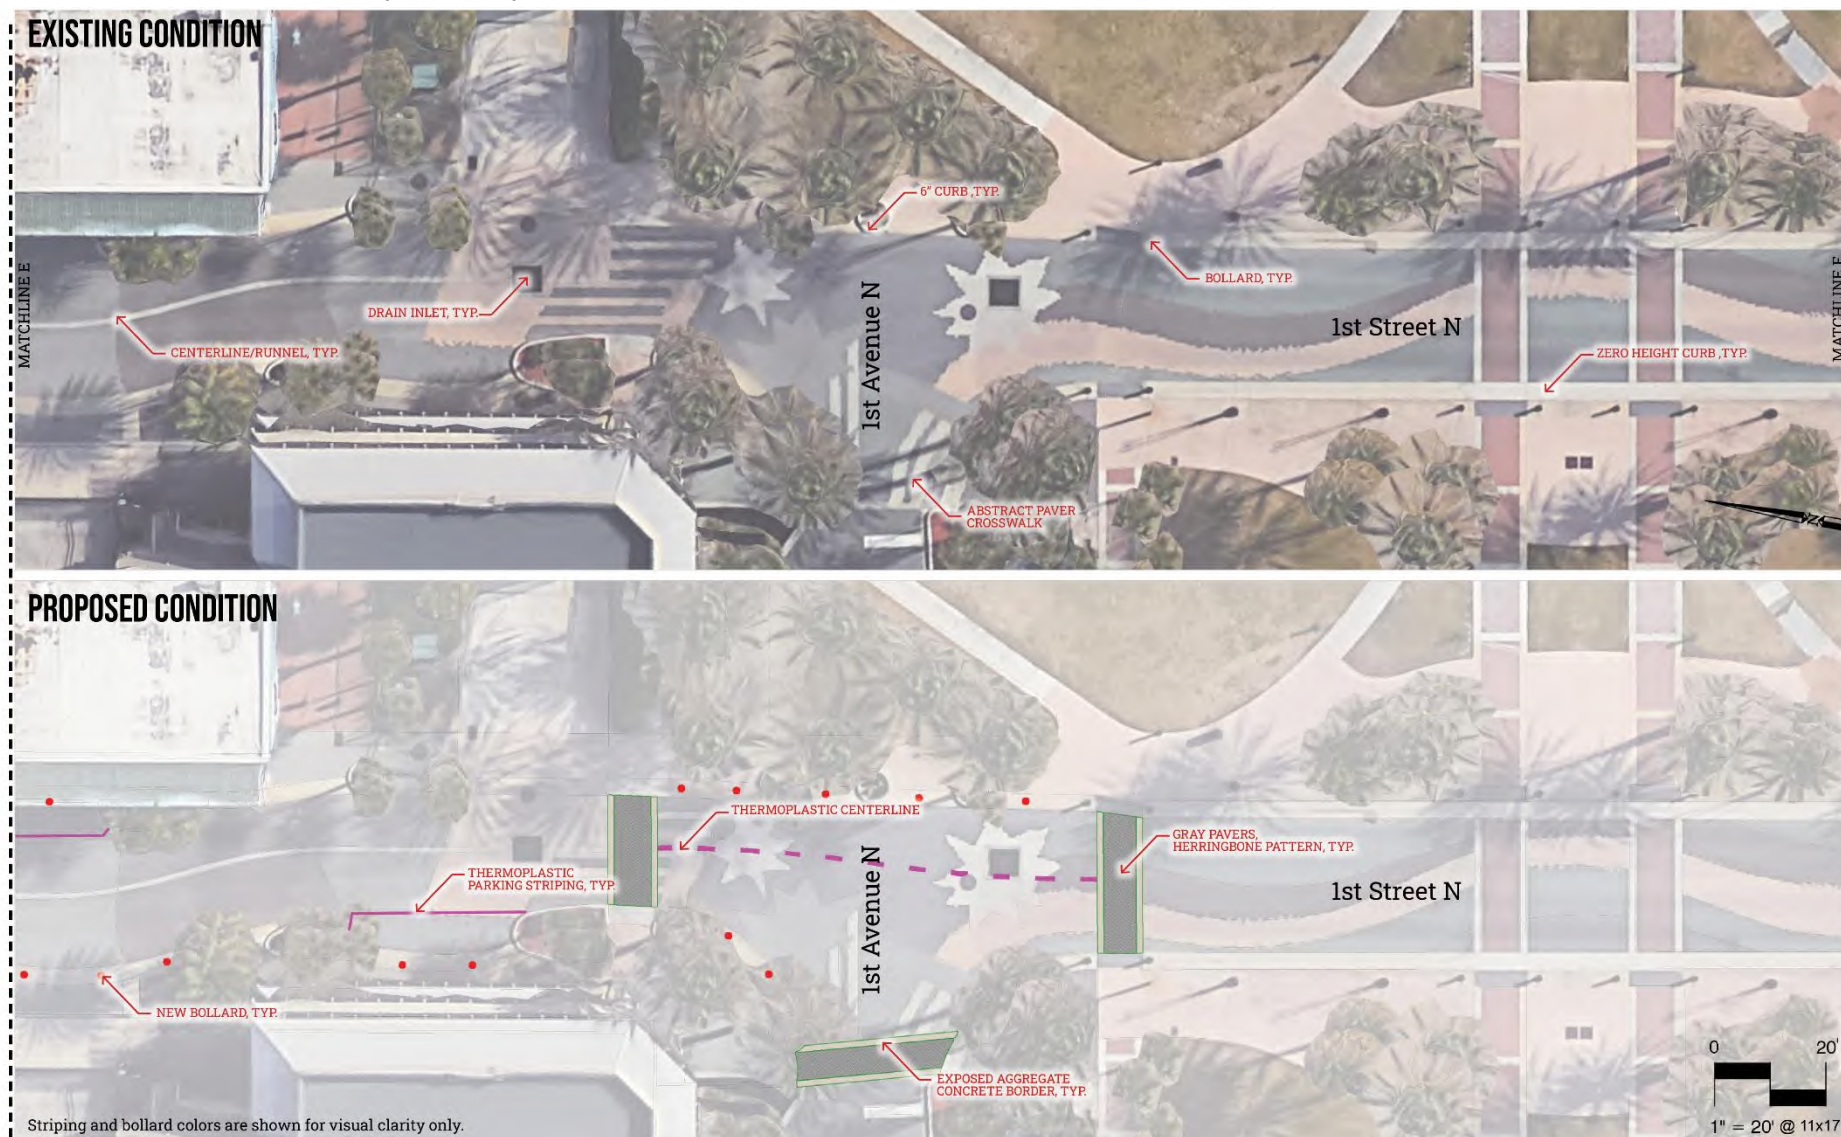
## 1st Avenue N Streetscape Concept

### Proposed Improvements

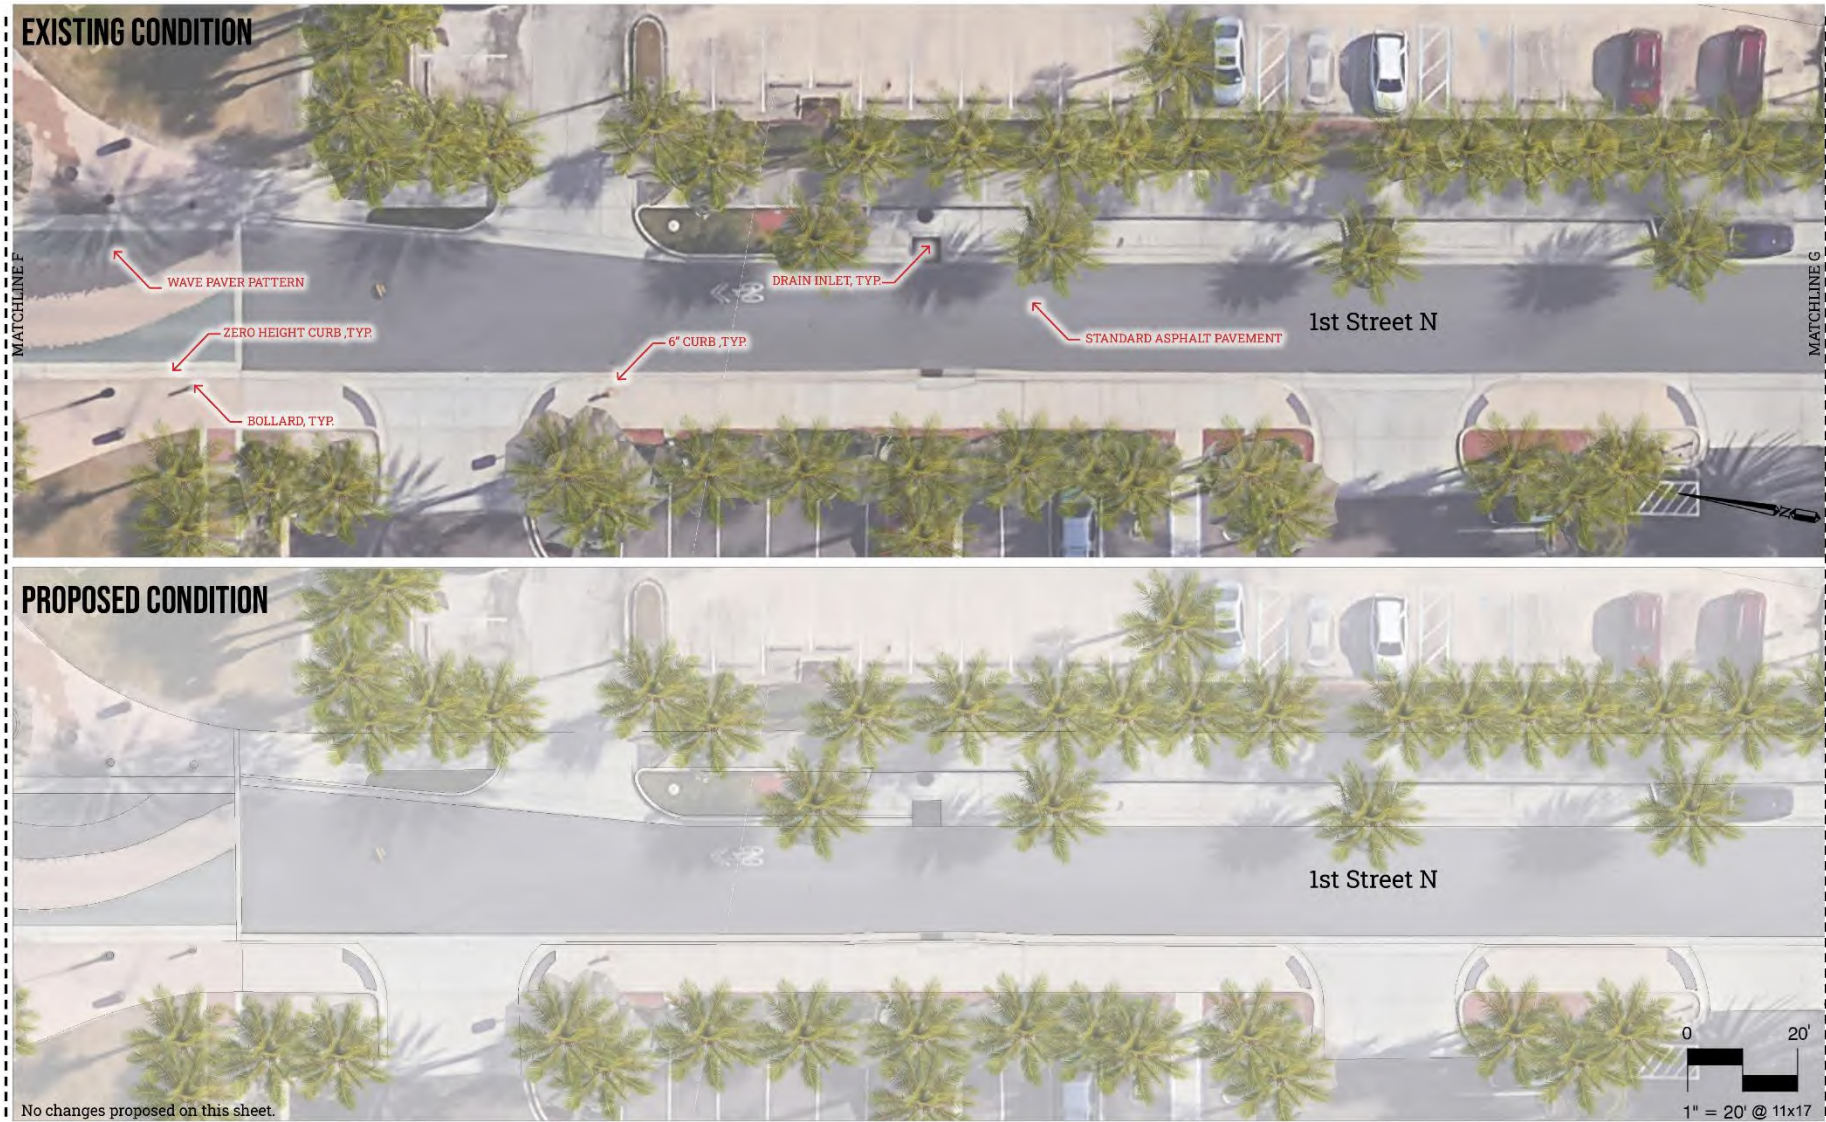
South of 1st Avenue N Streetscape Concept

Proposed Improvements

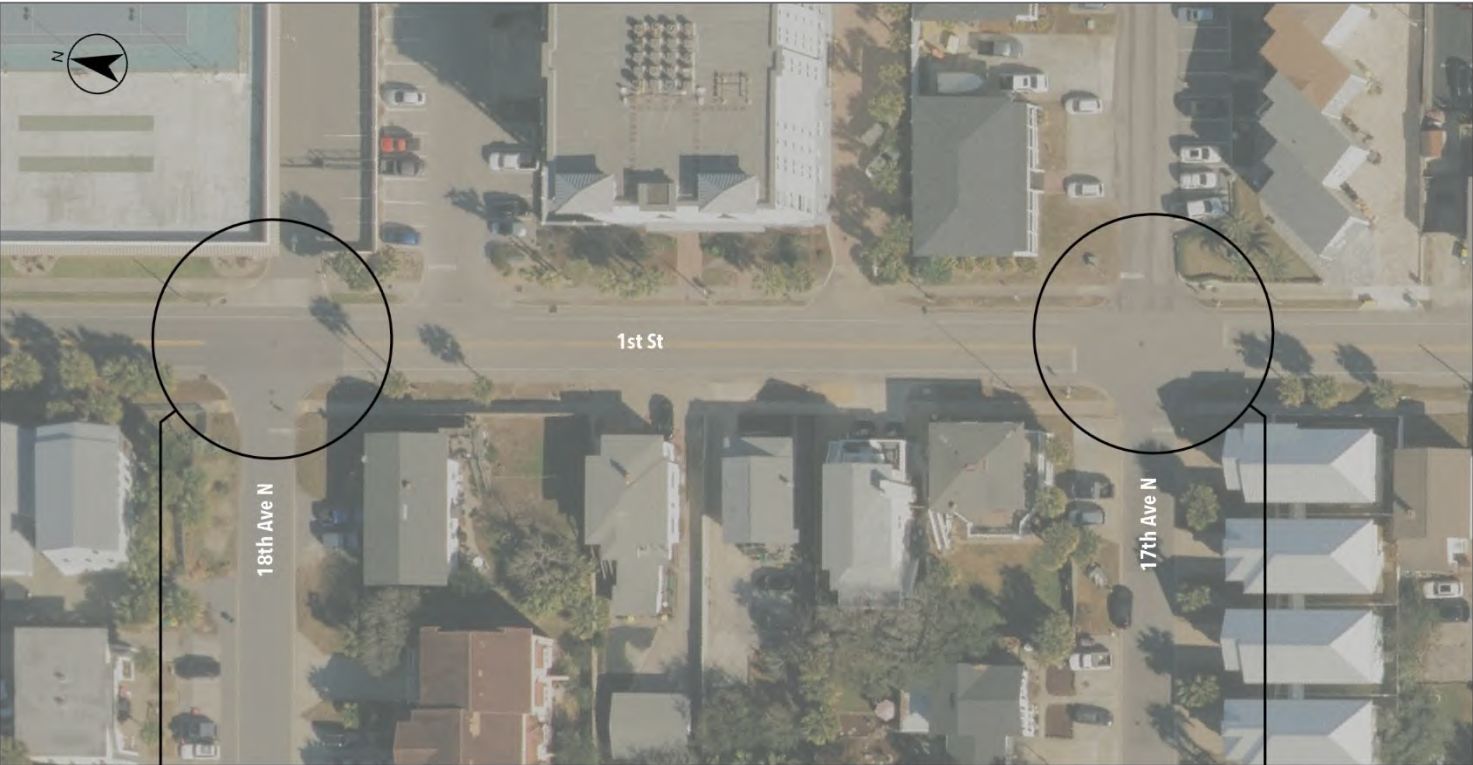
18th Avenue North to 17th Avenue North - Character Area 2

Add crosswalk

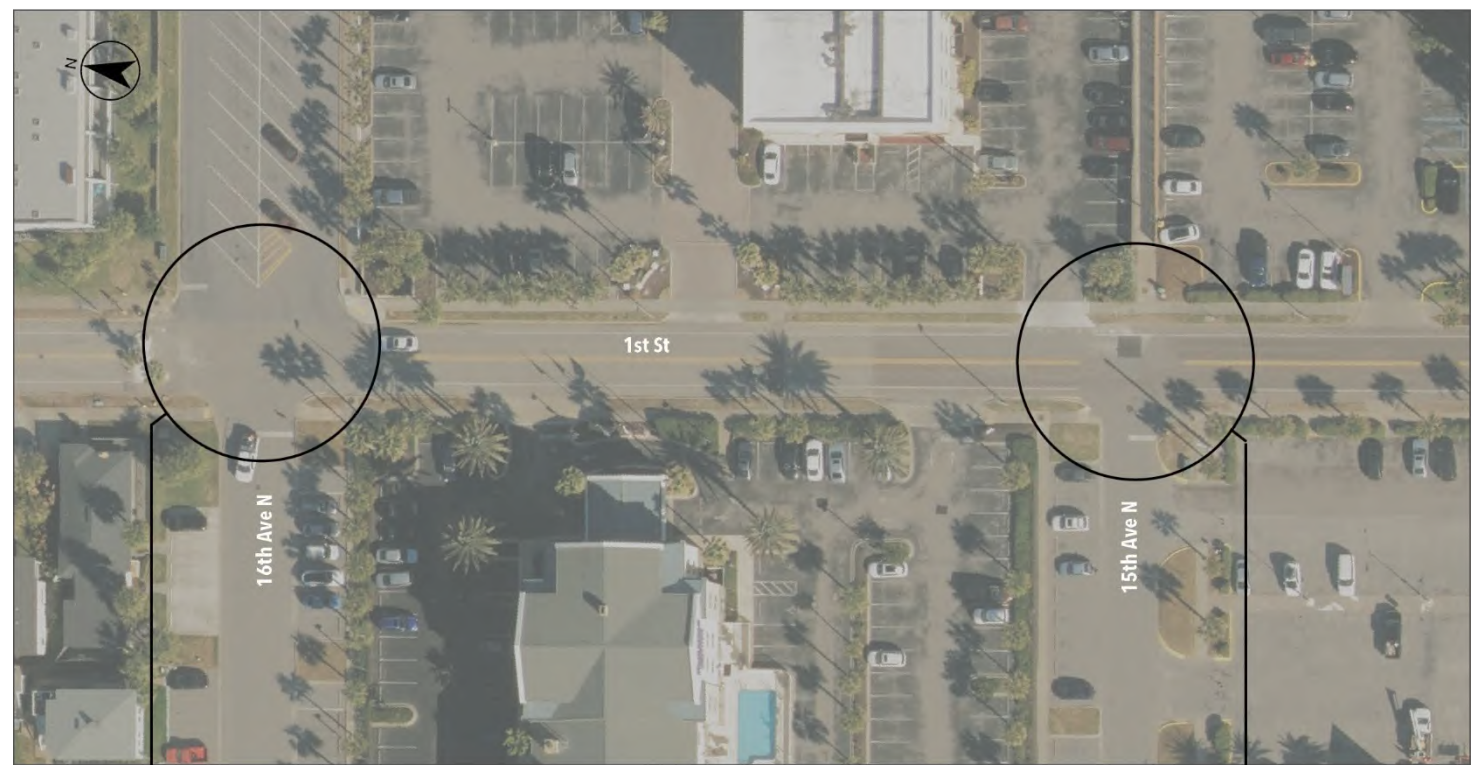
16th Avenue North to 15th Avenue North - Character Area 2

Add crosswalks  
Add raised island to delineate parking area

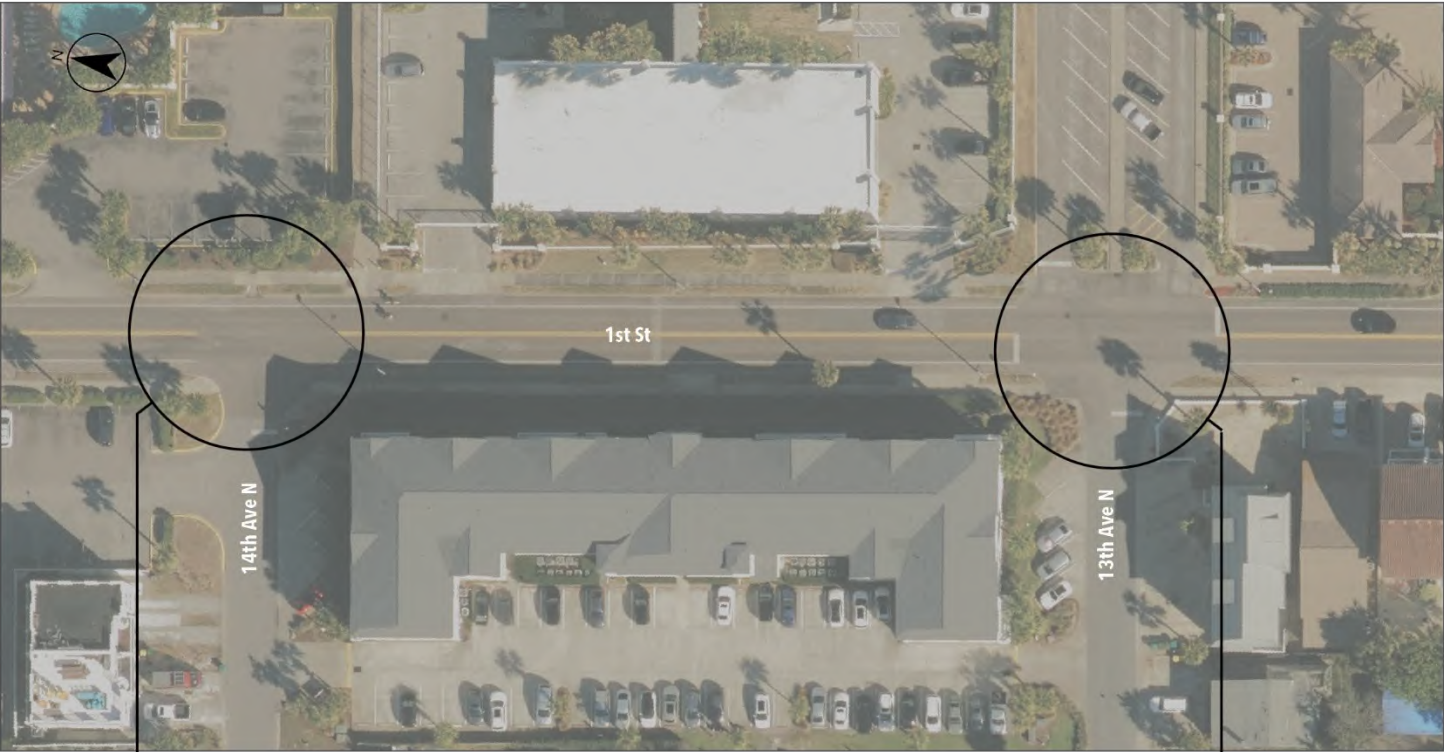
14th Avenue North to 13th Avenue North - Character Area 2

Add crosswalk  
Add raised crosswalk

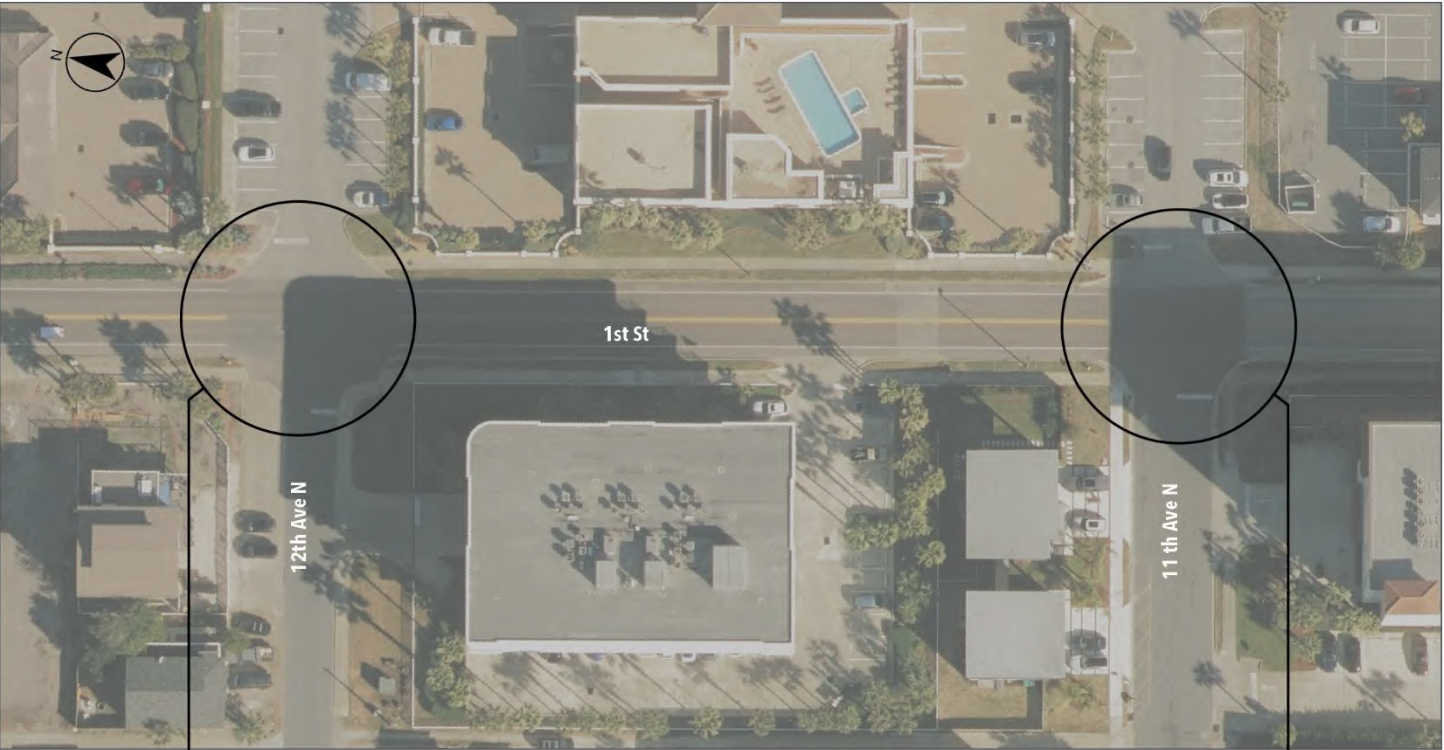
12th Avenue North to 11th Avenue North - Character Area 2

Add crosswalk  
Reconstruct curb on SW corner
