# FIRST STREET BICYCLE AND PEDESTRIAN SAFETY STUDY

Jacksonville Beach, FL

July 2026

# First Street Bicycle & Pedestrian Safety Study

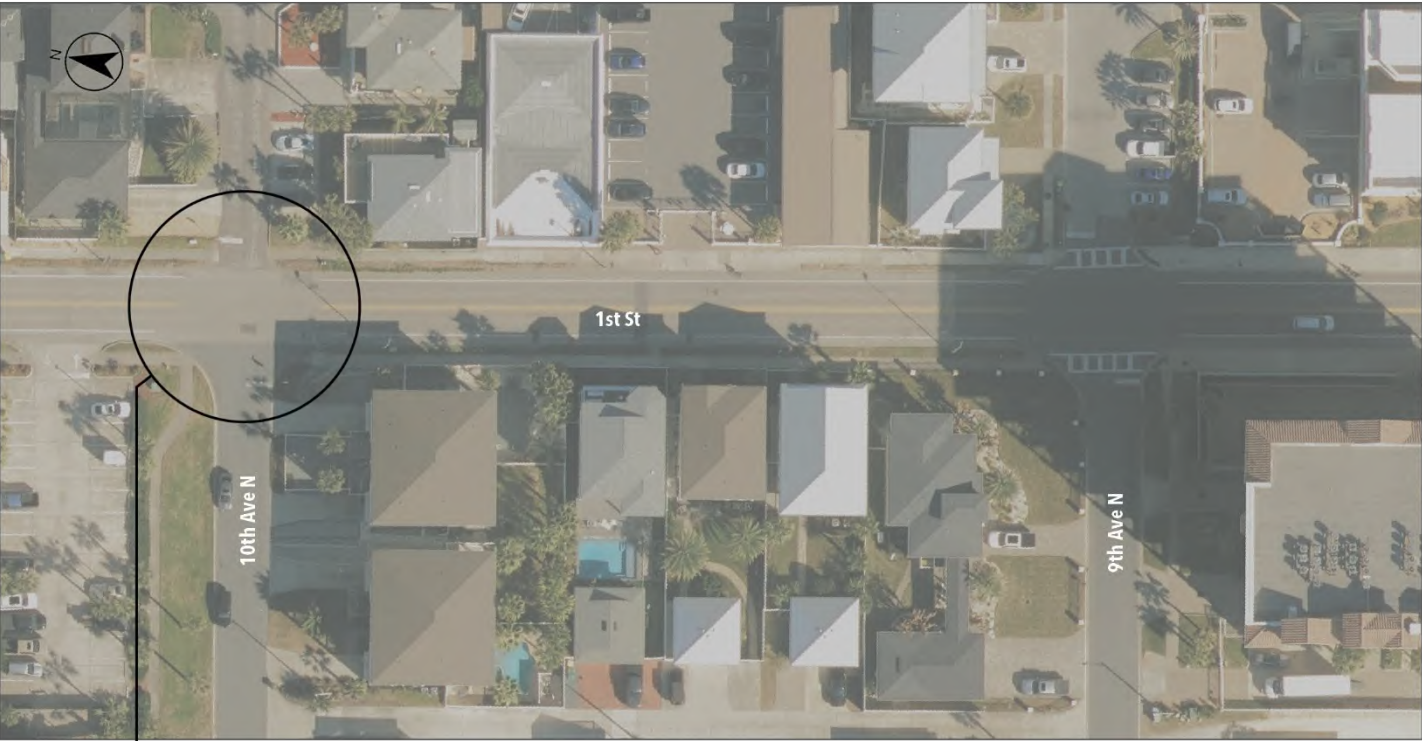
10th Avenue North to 9th Avenue North - Character Area 2

Add crosswalks  
Reconstruct curbs on NW and SW corners

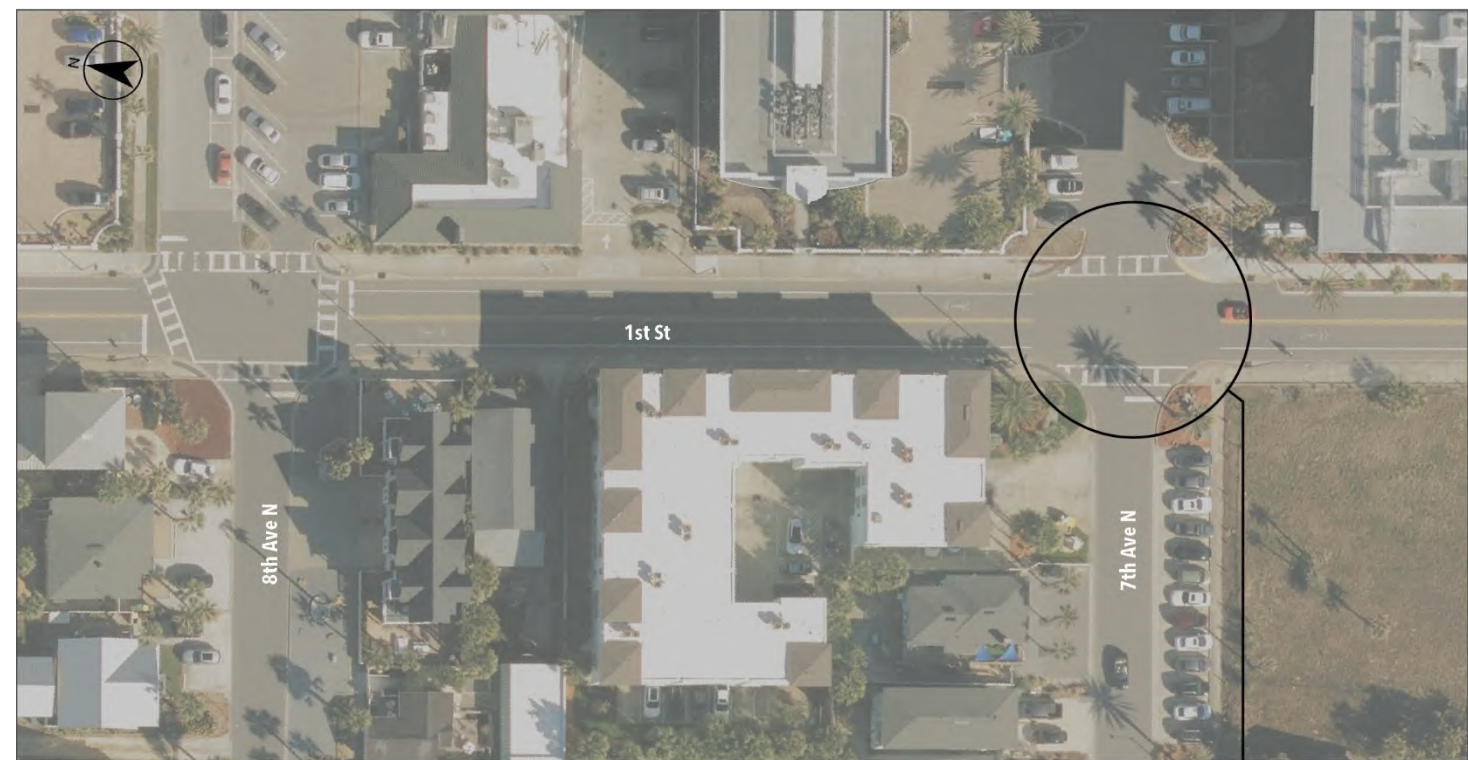
8th Avenue North to 7th Avenue North - Character Area 2

Add raised crosswalk

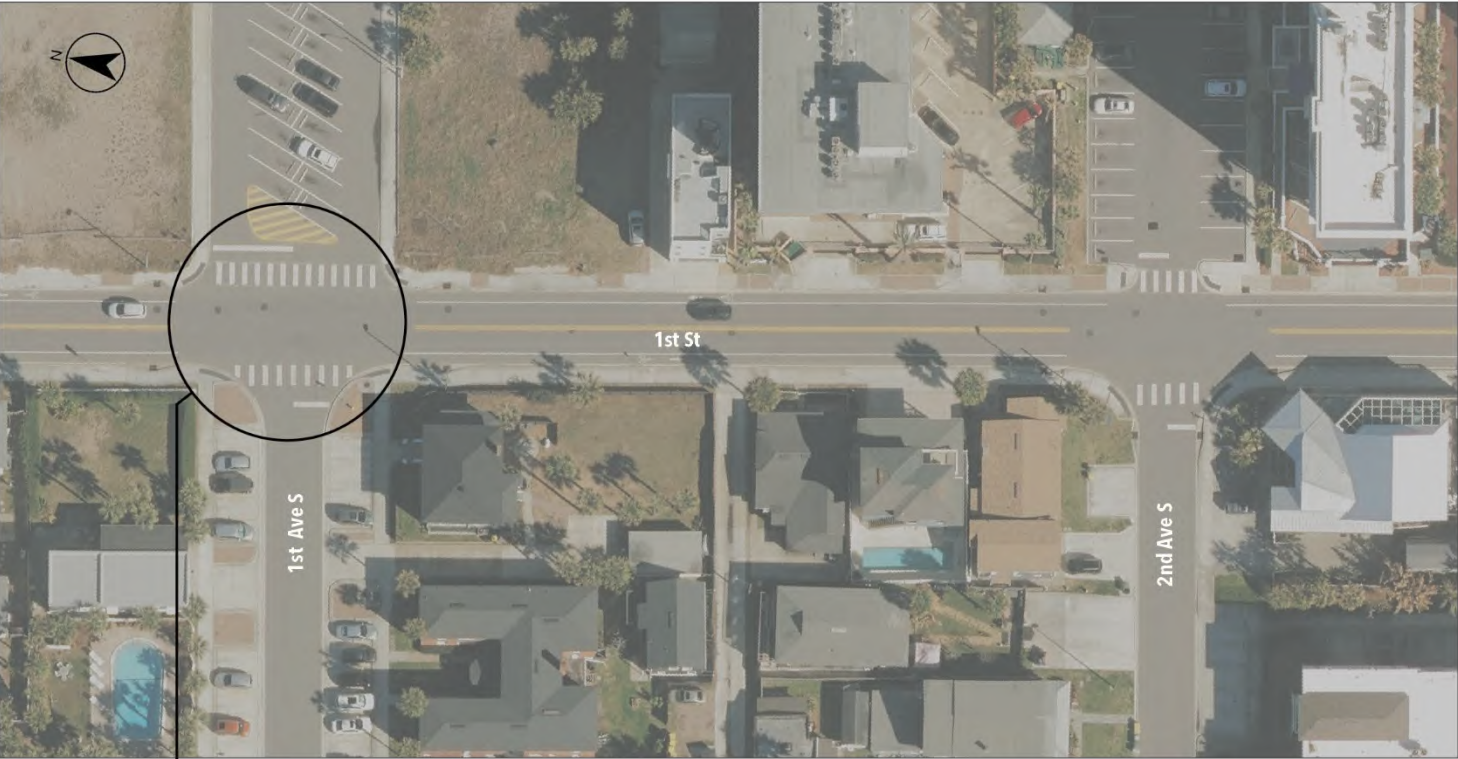
1st Avenue South to 2nd Avenue South - Character Area 2

Add raised crosswalk

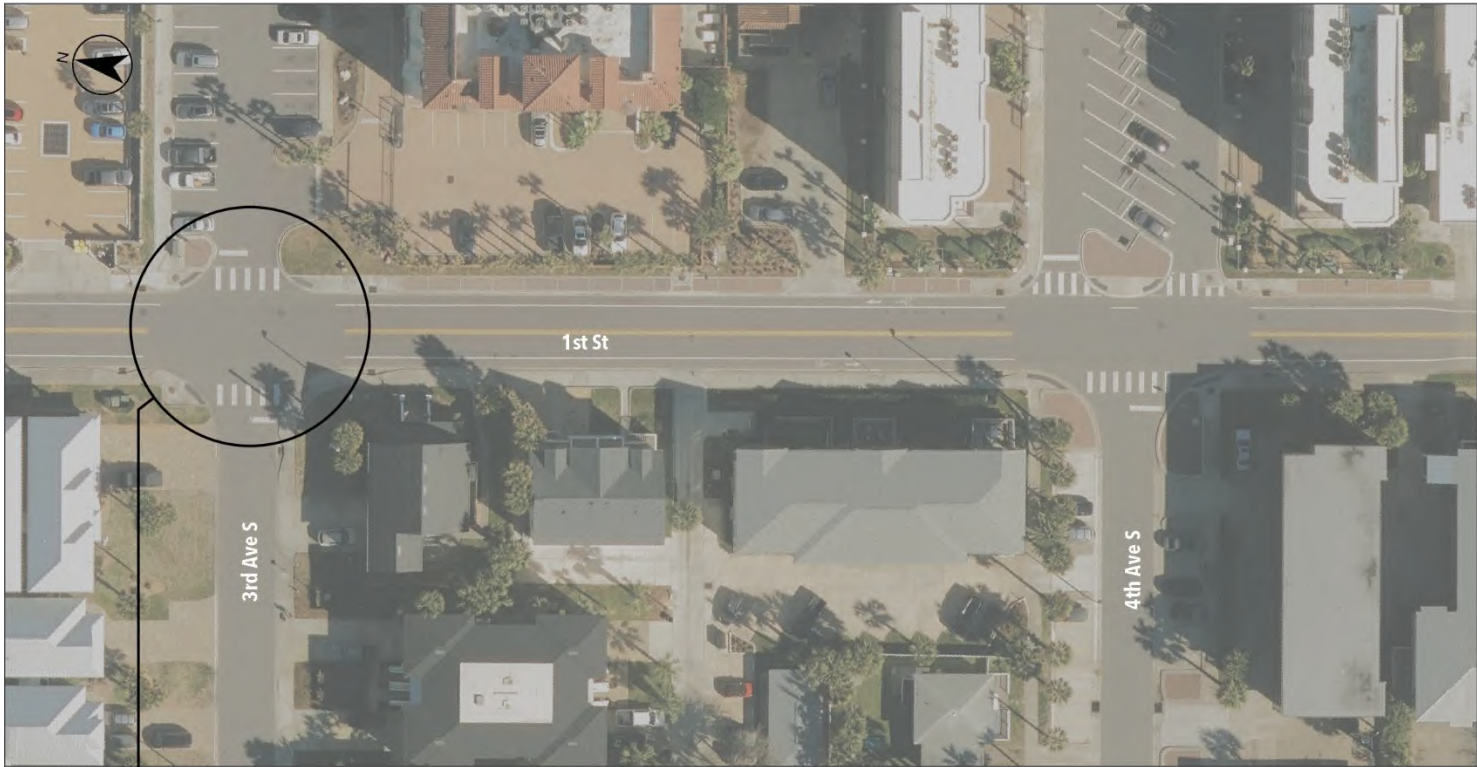
3rd Avenue South to 4th Avenue South - Character Area 2

Add raised crosswalk

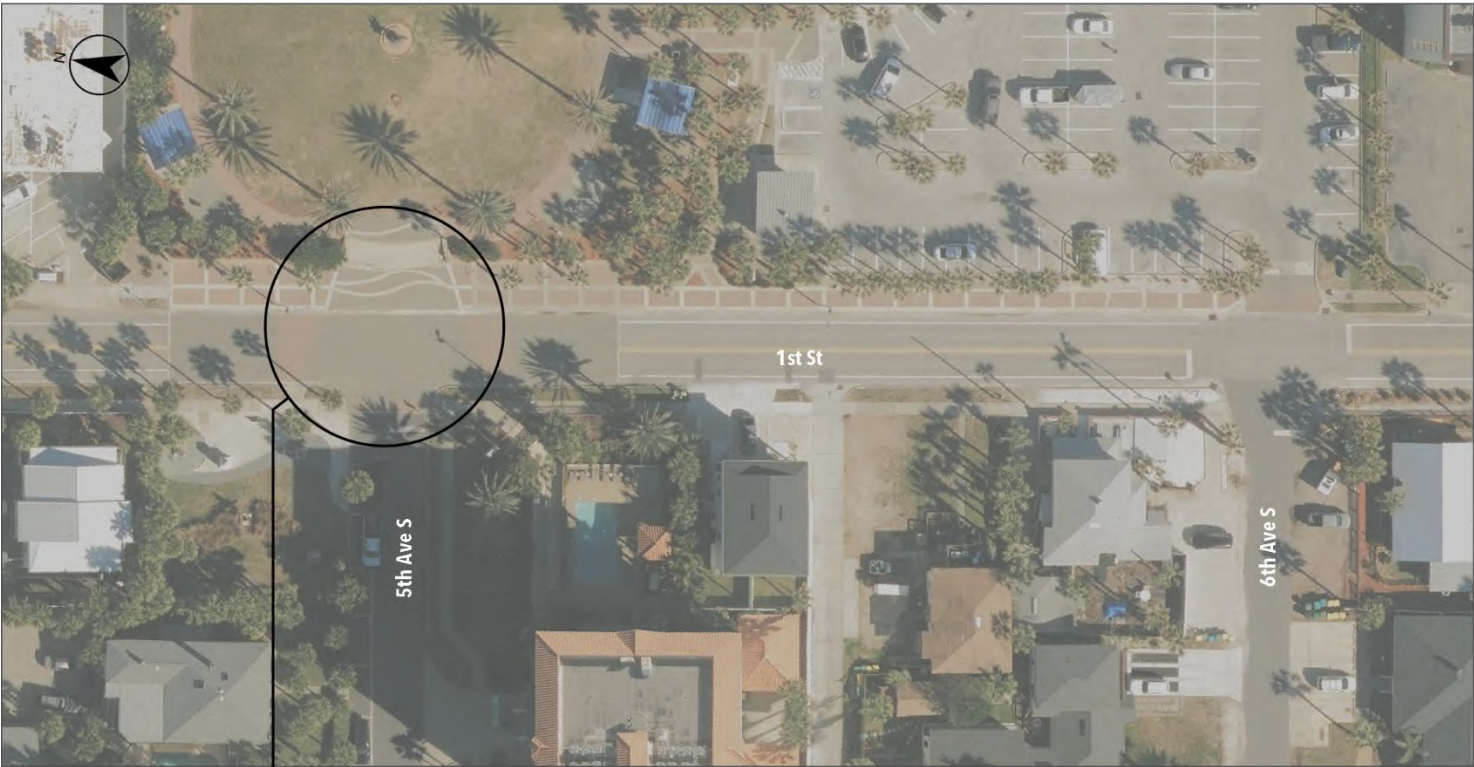
5th Avenue South to 6th Avenue South - Character Area 2

Add raised crosswalk

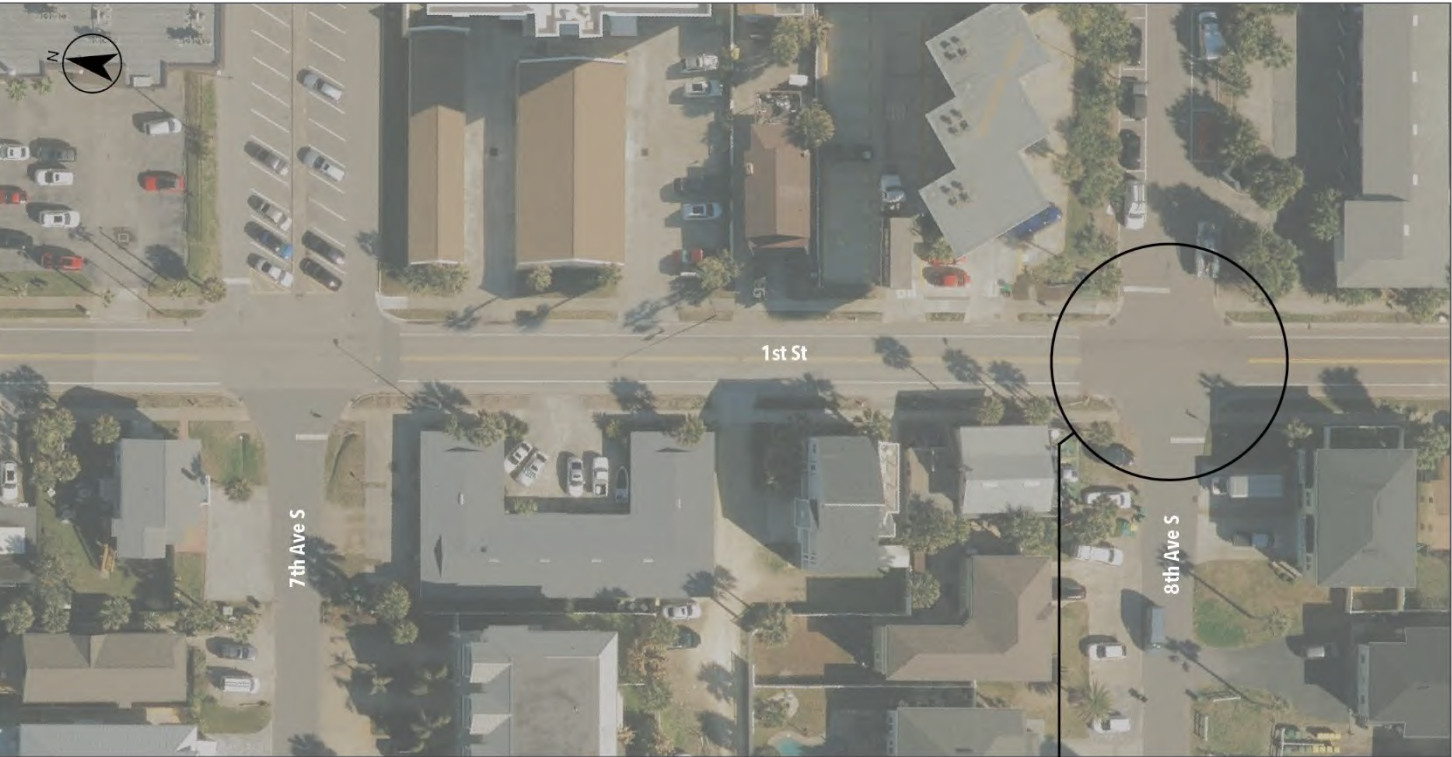
7th Avenue South to 8th Avenue South - Character Area 2

*\*This aerial image does not reflect recently painted crosswalks*

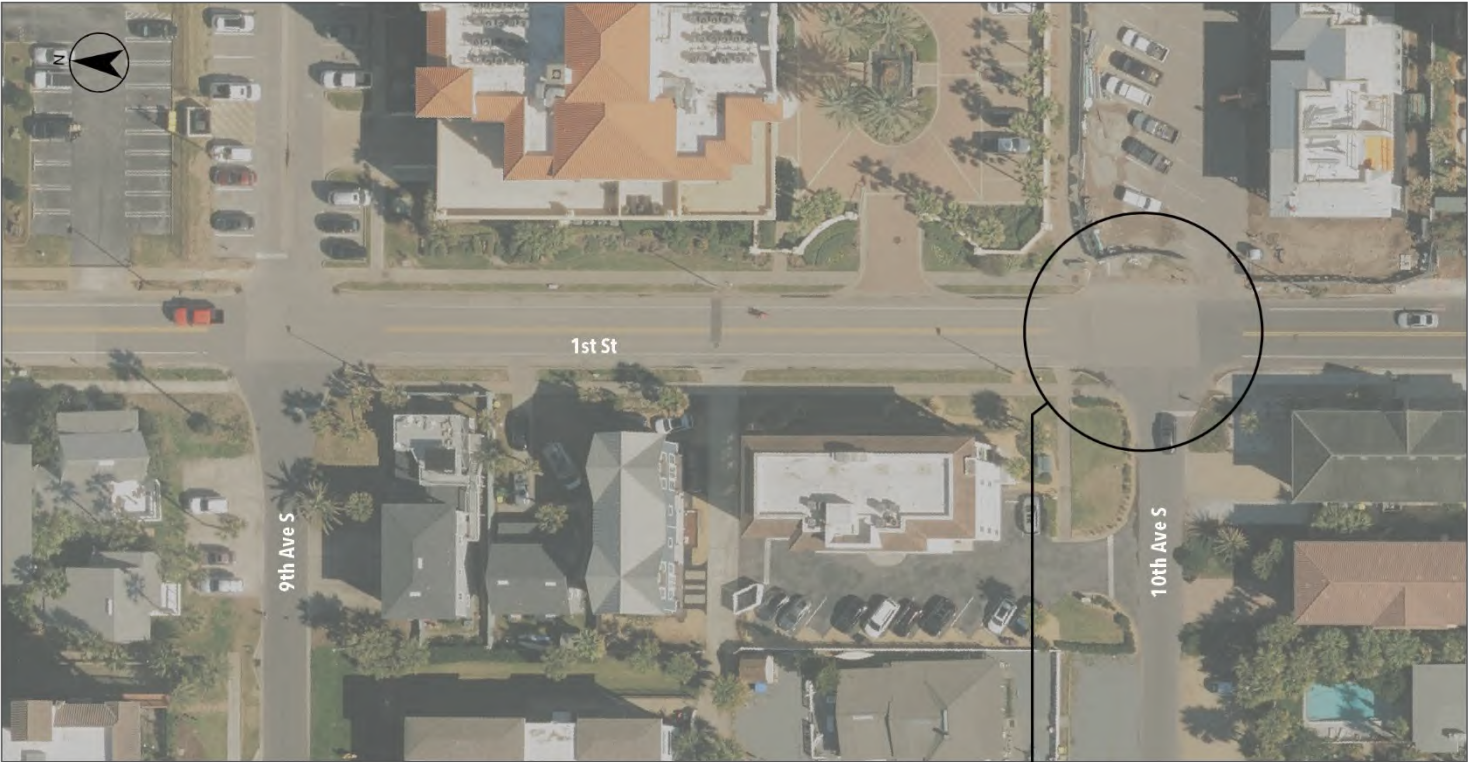
9th Avenue South to 10th Avenue South - Character Area 2

*\*This aerial image does not reflect recently painted crosswalks*

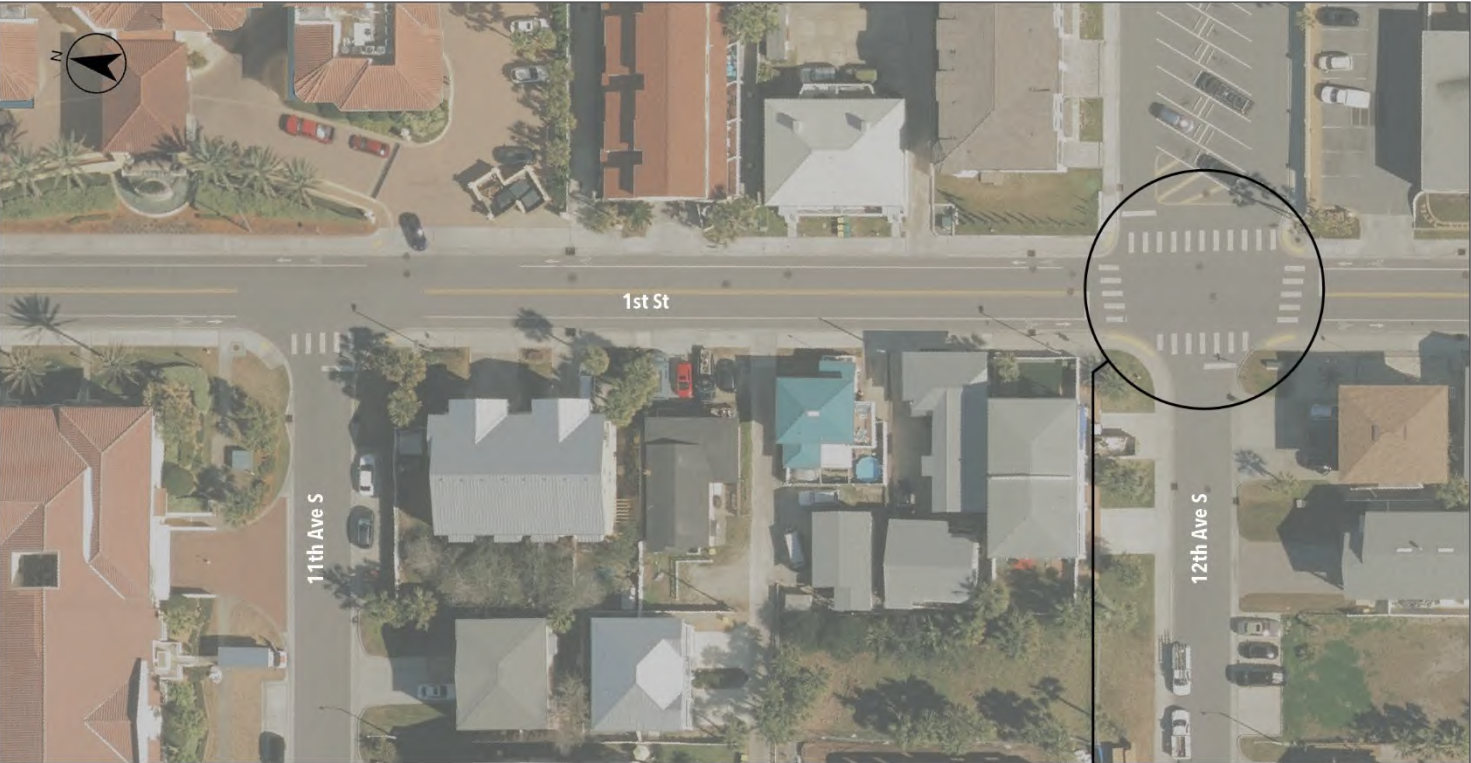
11th Avenue South to 12th Avenue South - Character Area 2

Add raised island to delineate parking area

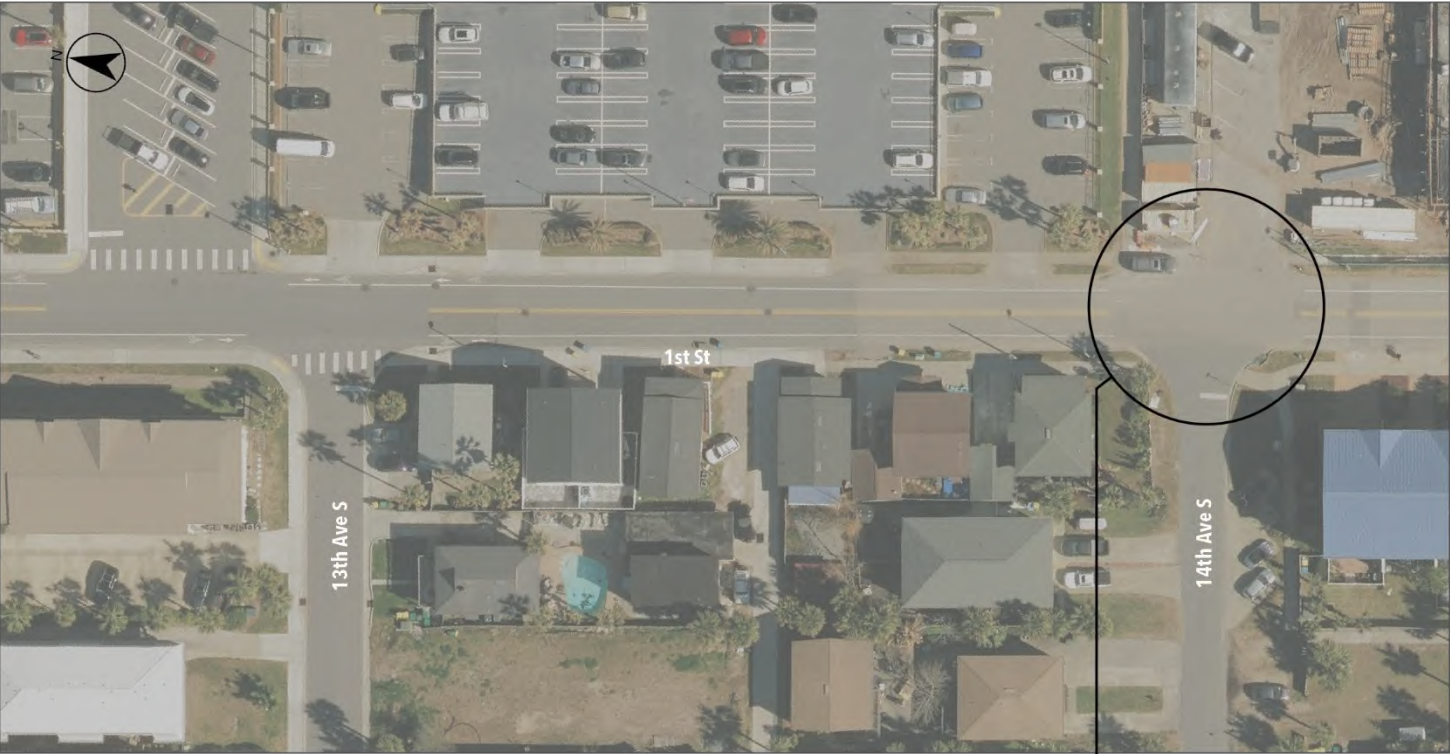
13th Avenue South to 14th Avenue South - Character Area 2

Add crosswalks  
Add raised island to delineate parking area

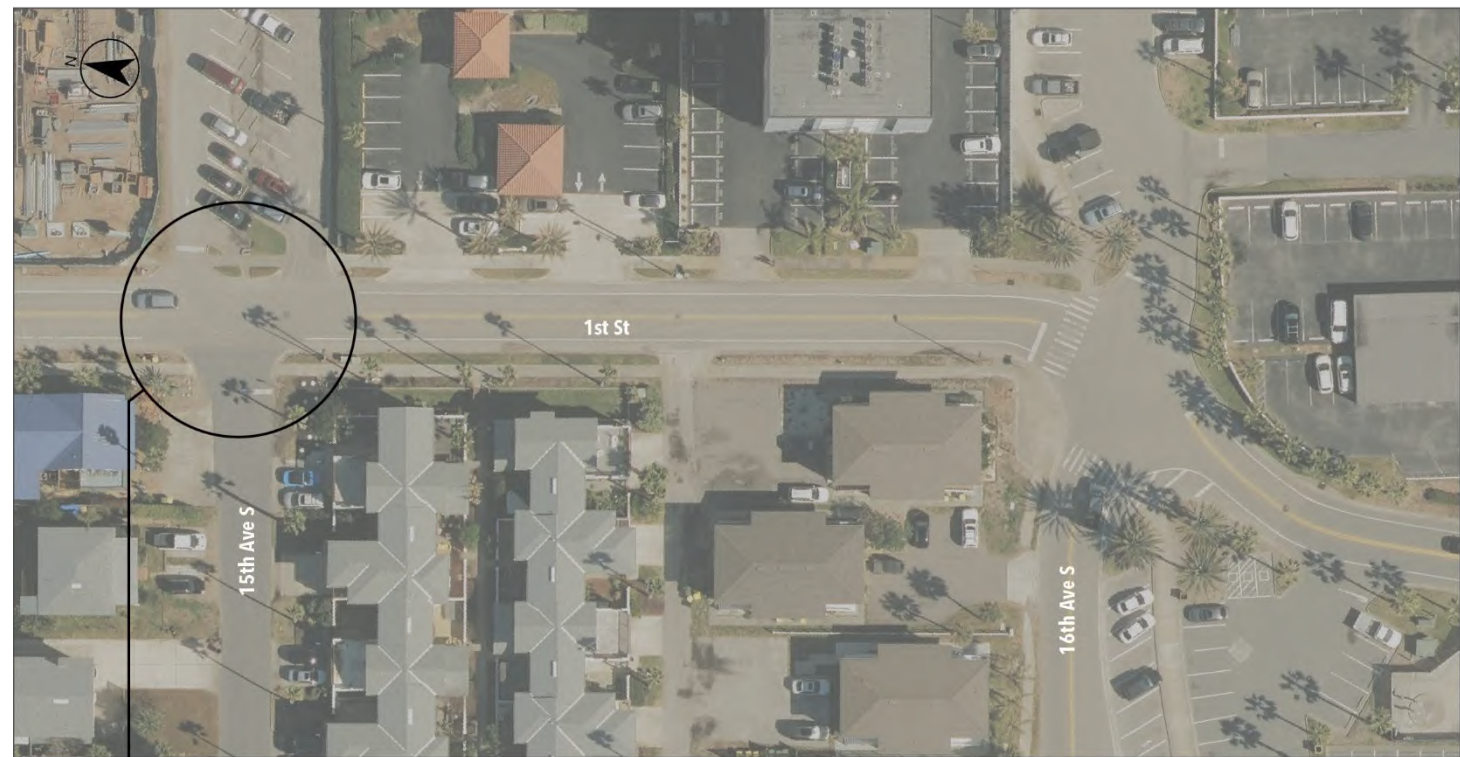
15th Avenue South to 16th Avenue South - Character Area 2

Add crosswalks

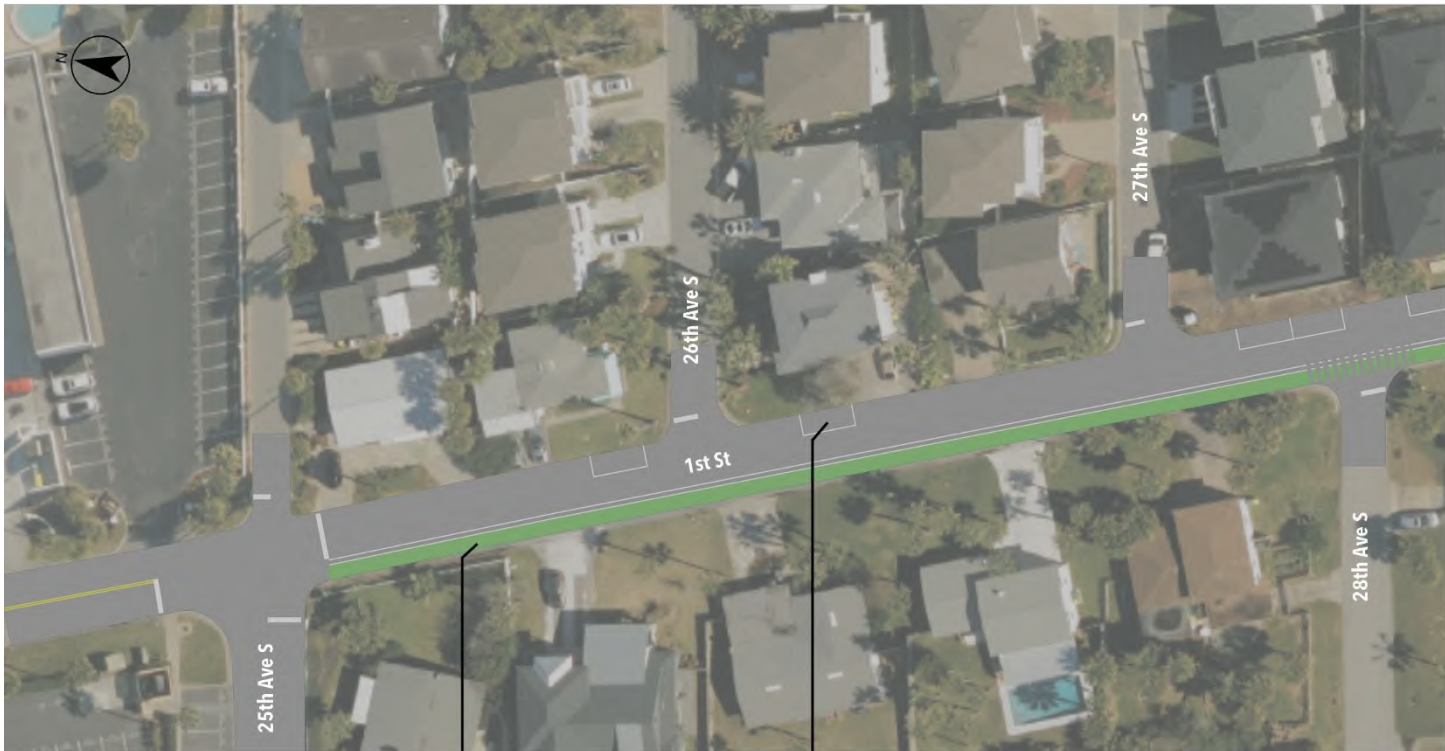
25th Avenue South to 28th Avenue South - Character Area 4

Add 8' on-street multimodal path (green paint optional)

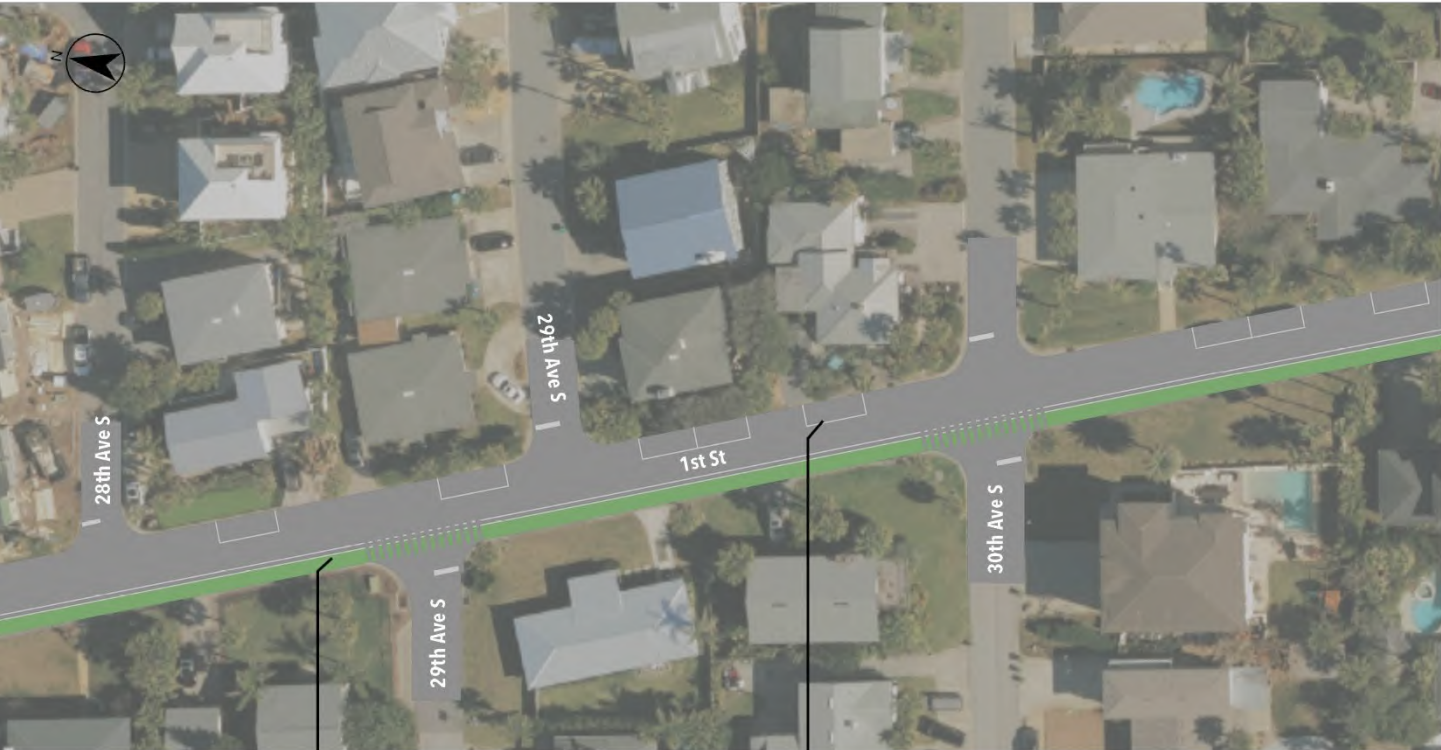
28th Avenue South to 30th Avenue South - Character Area 4

Add 8' on-street multimodal path (green paint optional)

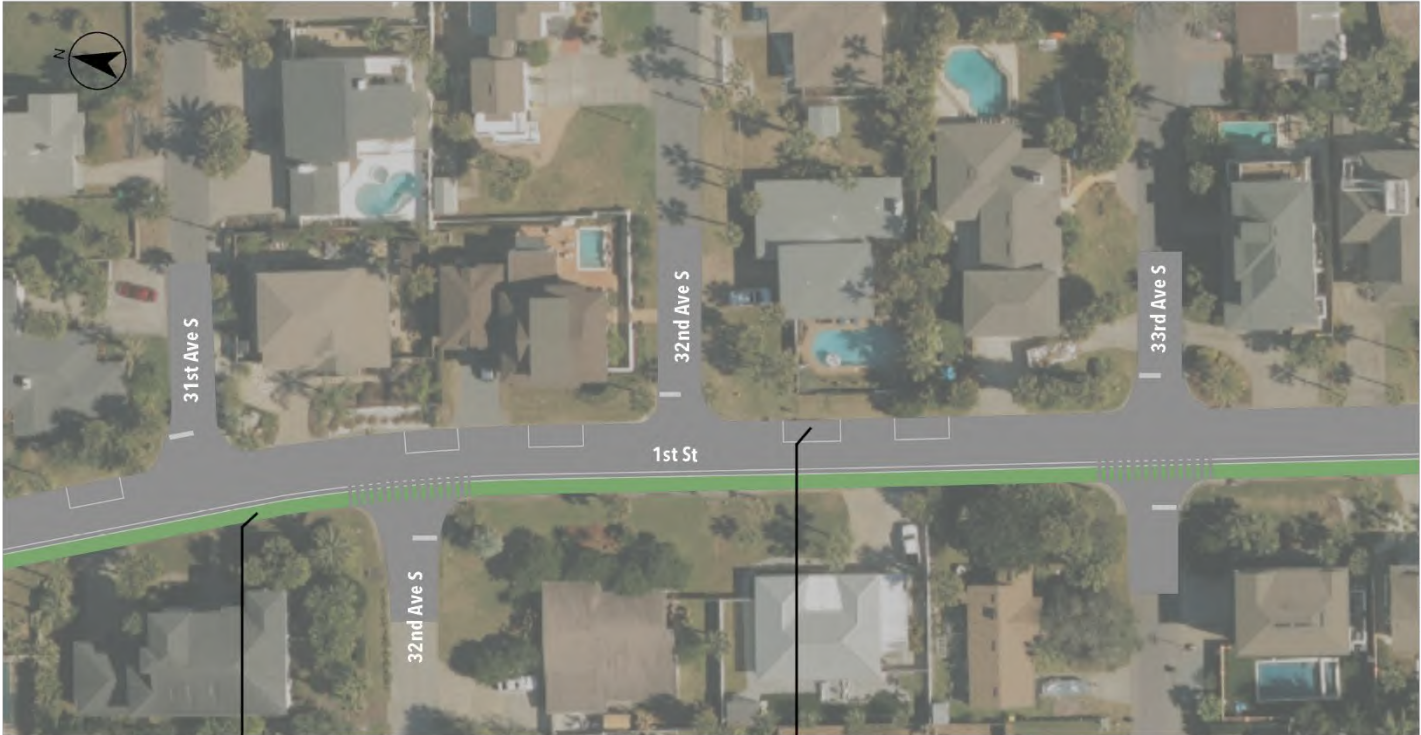
31st Avenue South to 33rd Avenue South - Character Area 4

Add 8' on-street multimodal path (green paint optional)

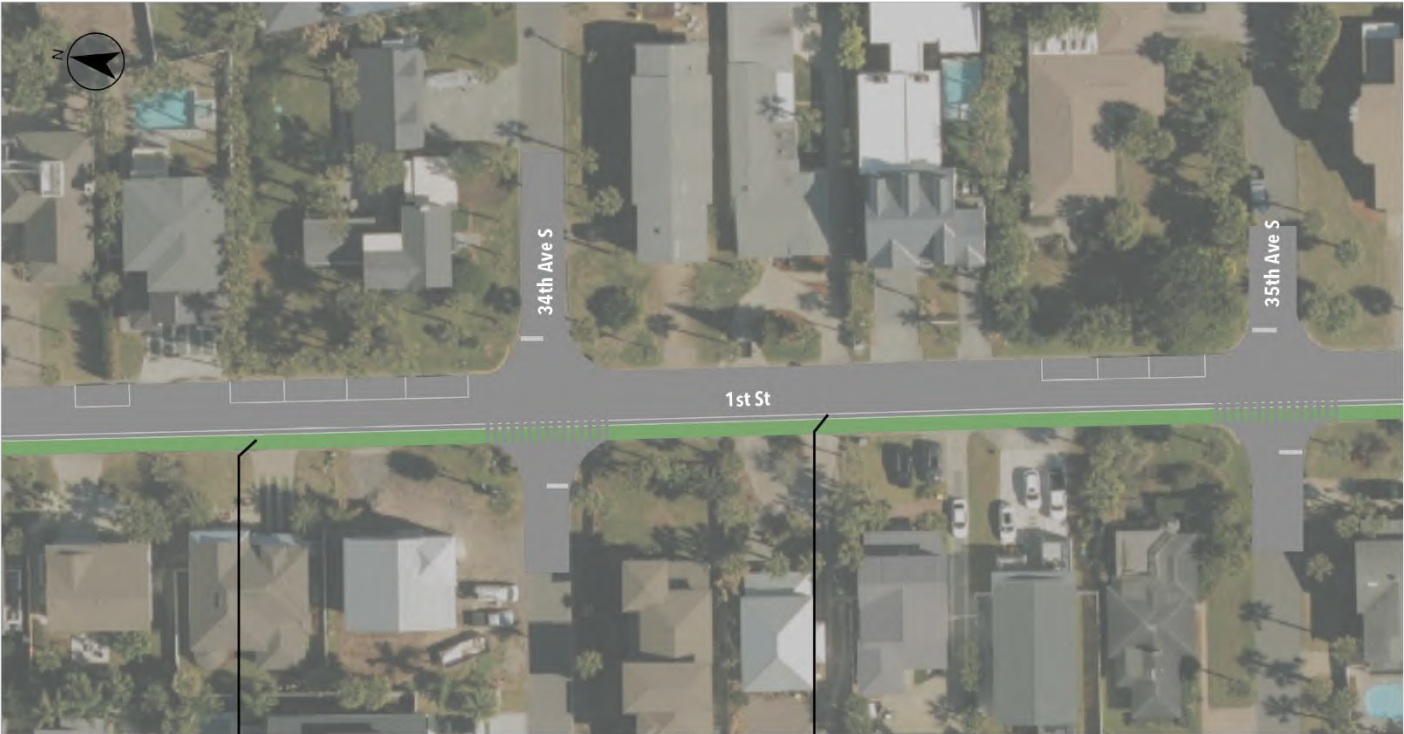
34th Avenue South to 35th Avenue South - Character Area 4

Add 8' on-street multimodal path (green paint optional)

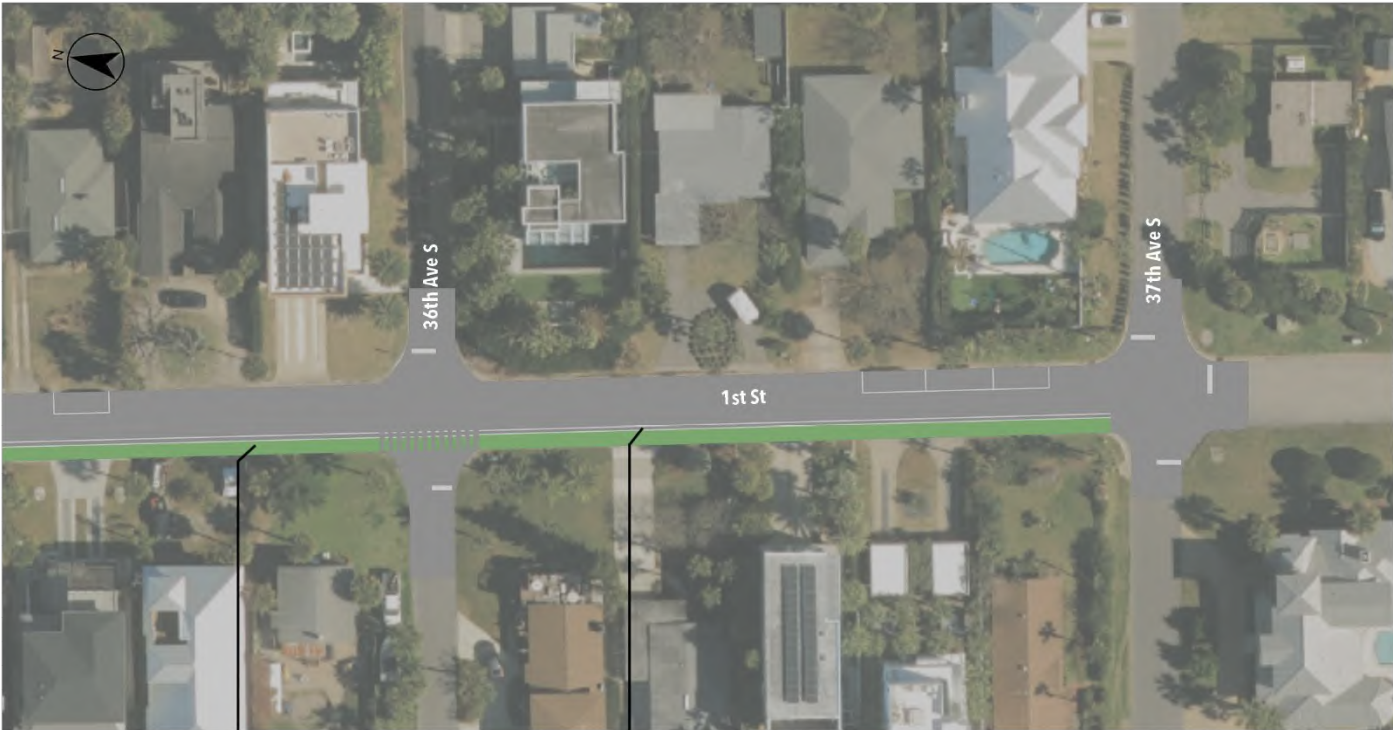
36th Avenue South to 37th Avenue South - Character Area 4

Add 8' on-street multimodal path (green paint optional)

Add 2' buffer between pathway and travel lane
